# Organic Finishing Technologies

## B-52 Paint Life Cycle Extension

**Steve Finley, CTC**  
**Support Contractor to**  
**Mr. Tom Naguy**  
**Air Force Research Laboratory**

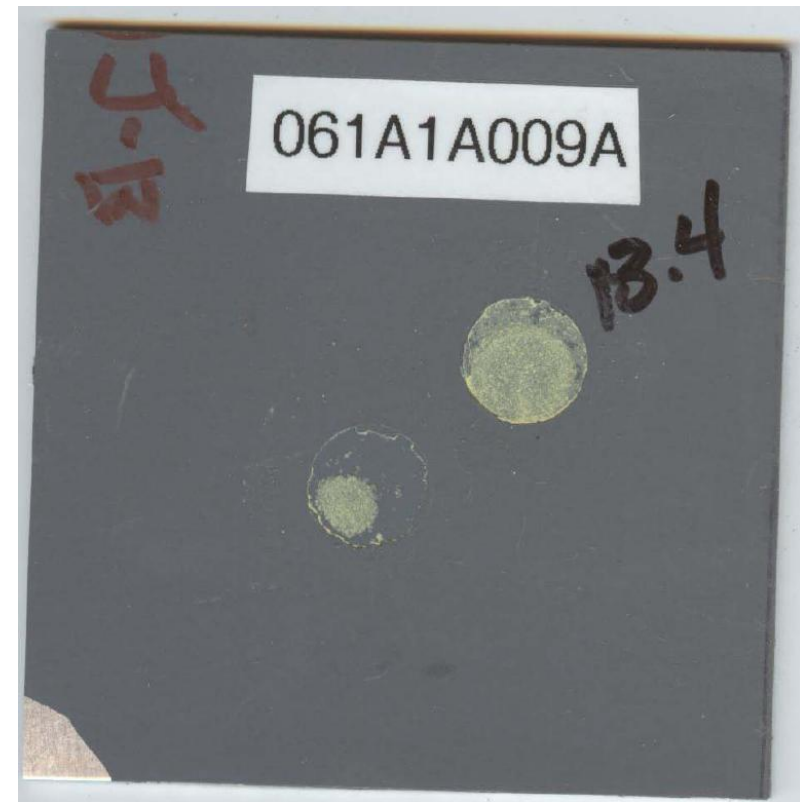
- Adhesion Testing using Pneumatic Adhesion Tensile Testing Instrument (PATTI) results
  - Six panels with two pulls per panel
  - Predominant failure mode was cohesive failure at the primer
  - Three panels showed adequate pull strength
  - Three panels were lower than desired

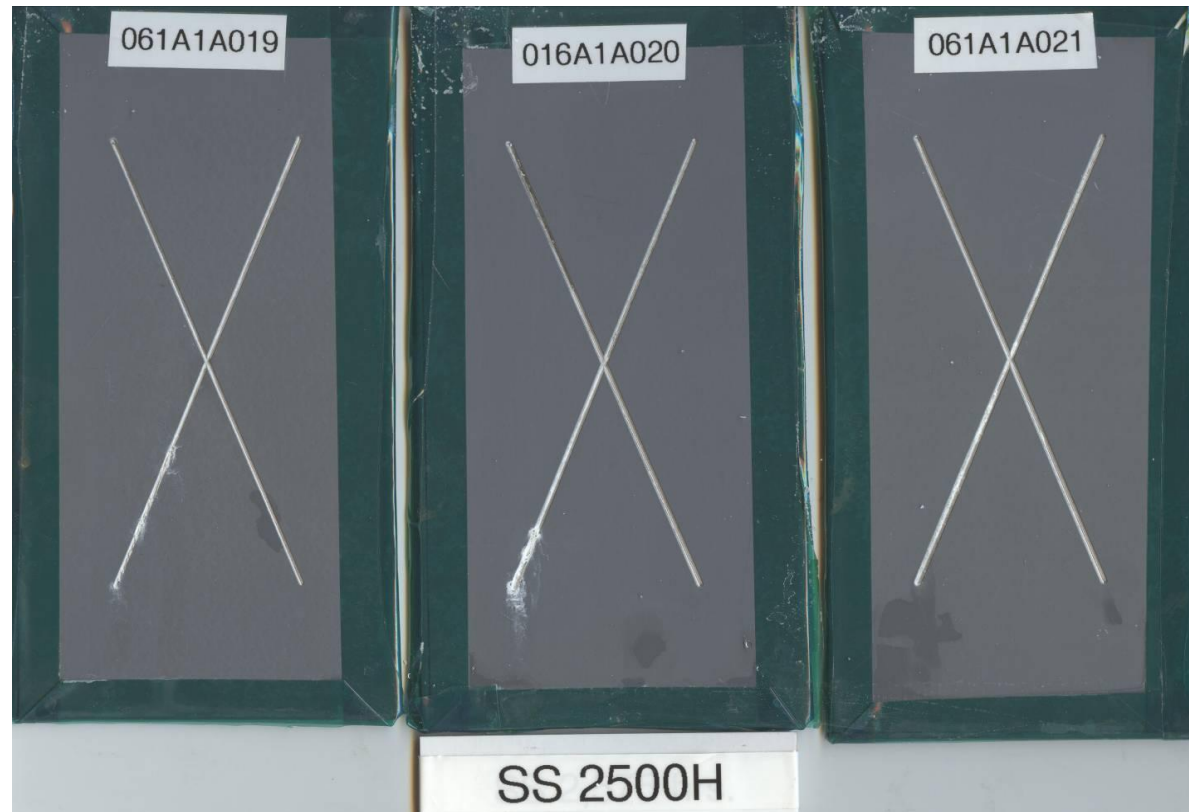
- Tested in accordance with ASTM B-117 *Standard Practice for Operating Salt Fog Apparatus*
- Slight corrosion in the scribe at 500 hours; no change for the remainder of testing

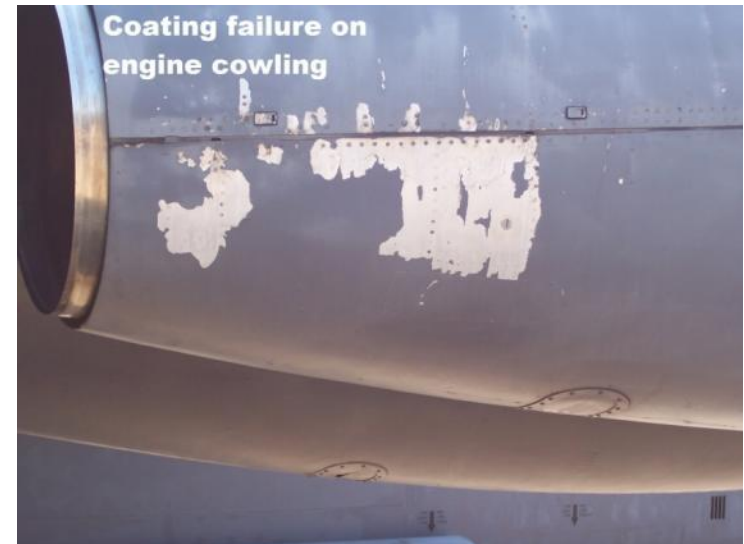
- **Barksdale Inspection Results**
  - **Several adhesion failures noted on multiple aircraft**
  - **No corrosion was detected during the visual inspection**
  - **No facility to accomplish maintenance touch up**
  - **Color, gloss, and film thickness readings taken on the two aircraft with advanced performance coating (APC)**

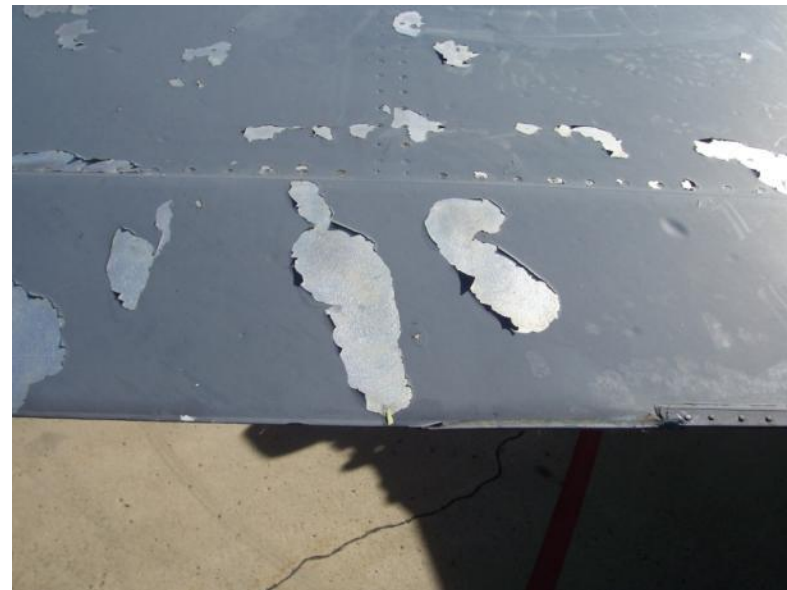
- Several adhesion failures noted on multiple aircraft; some as large as 20 ft<sup>2</sup>
- No corrosion was detected during the visual inspection
- No facility to accomplish maintenance touch up
- Color, gloss, and film thickness readings taken on three APC aircraft

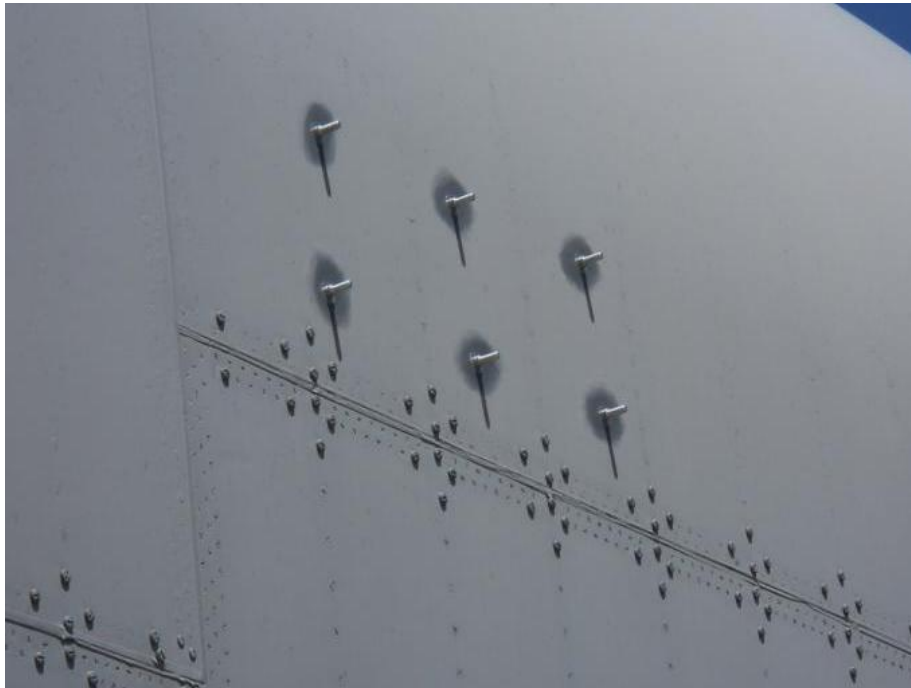
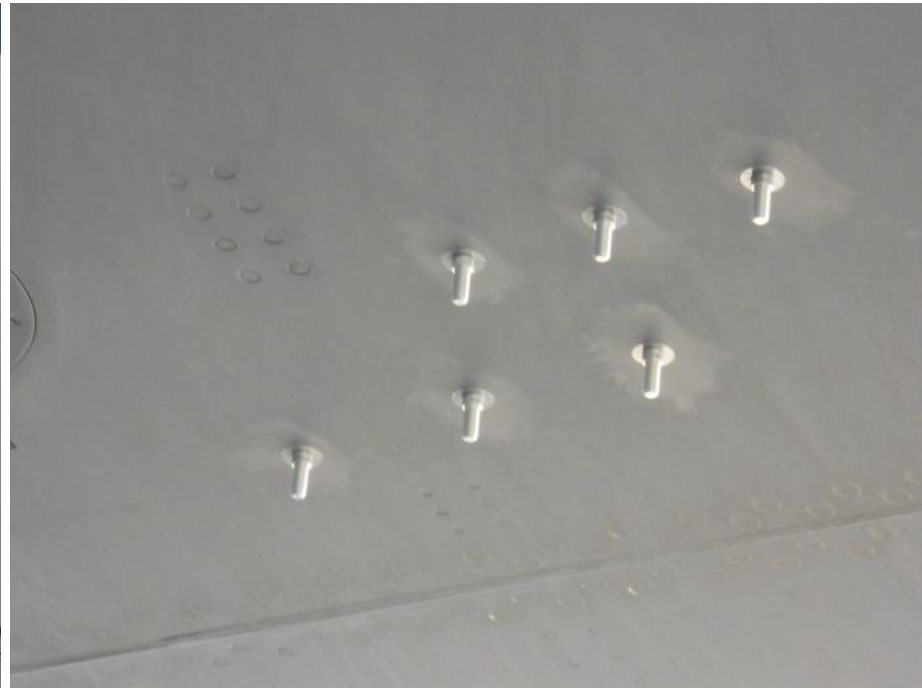
- Twelve studs glued to each aircraft
- Six under the right wing
- Six on the aft fuselage right side

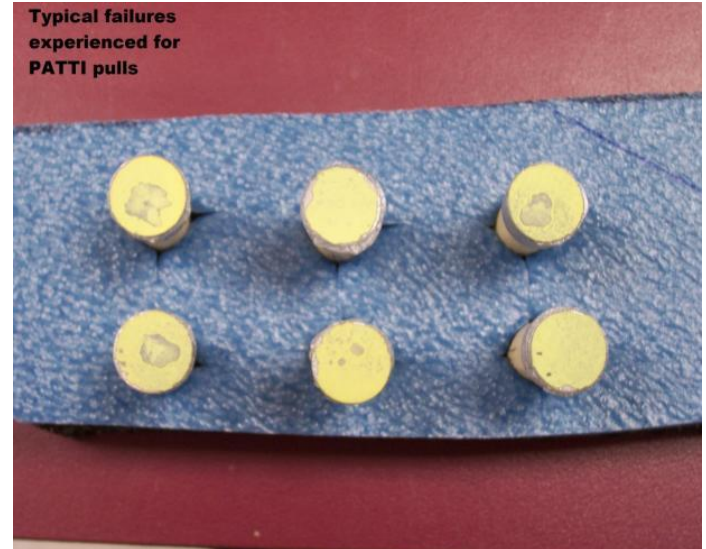
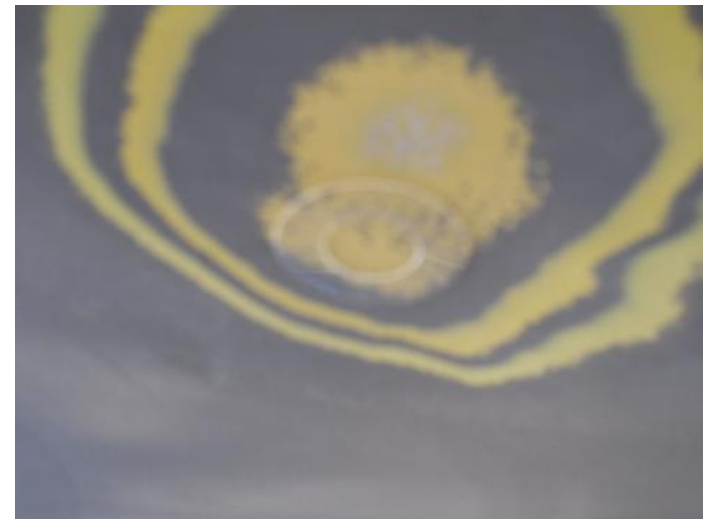
- **X-Ray Photoelectron Spectroscopy (XPS)**
  - Primer samples collected for XPS analysis
  - Coating was sanded to the base primer layer
  - Dust was collected on tape
  - PATTI studs were used for analysis
  - Fourteen samples were analyzed
- **Cr +6 level equal to or greater than fresh applied primer in 13 of 14 samples**
