Fluorescent Coatings for Corrosion Detection in Steel and Aluminum Alloys

H.G. Wheat and G. Liu
Mechanical Engineering Department
Texas Materials Institute
University of Texas at Austin
Austin, TX 78712

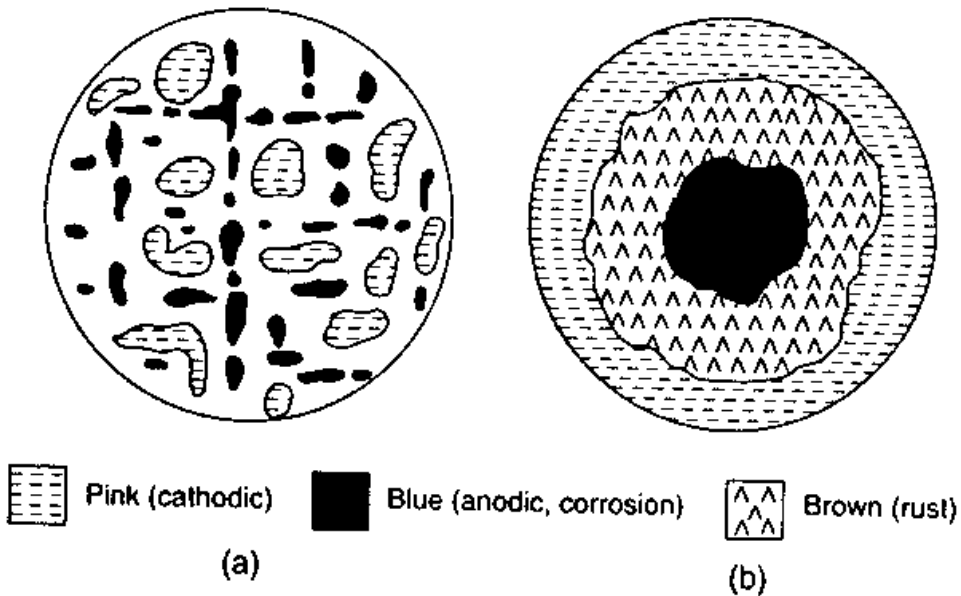
Figure 1. Initial (a) and final (b) distribution of anode and cathode in a water drop on a horizontal iron surface. (From U.R. Evans, *An Introduction to Metallic Corrosion*, Arnold, London, p. 36, 1981.)

Water droplet experiment: (A gel containing phenolphthalein and potassium ferricyanide is placed on a piece of steel.)

Phenolphthalein develops a reddish or pink color in the presence of hydroxyl ions and potassium ferricyanide develops a blue color upon reaction with ferrous ions.

Oxygen from the air is more accessible to the periphery of the drop and a pink color forms around the edges of the drop.

A blue color forms near the center of the drop where there is less access to oxygen.

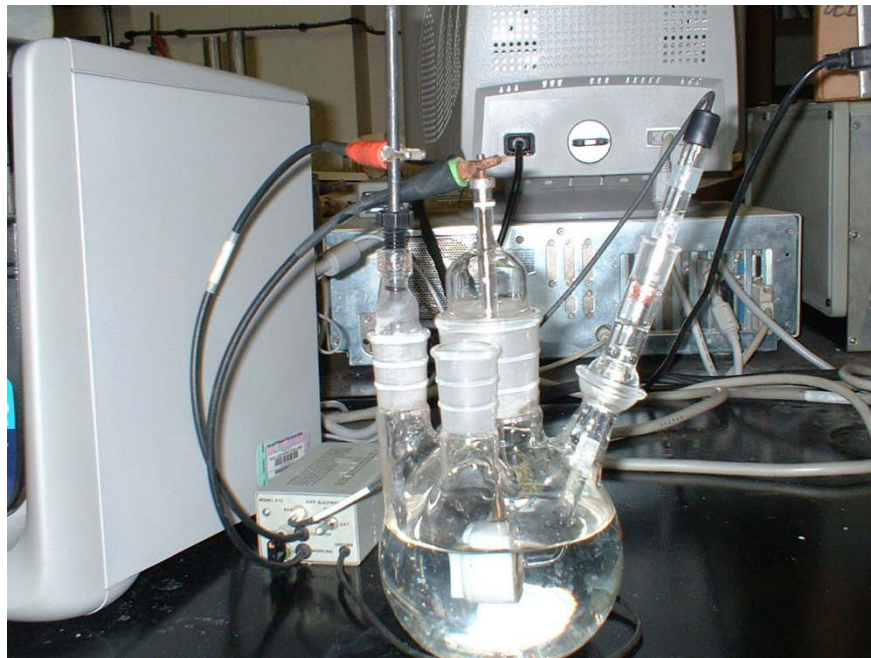
The setup for electrochemical testing using EIS

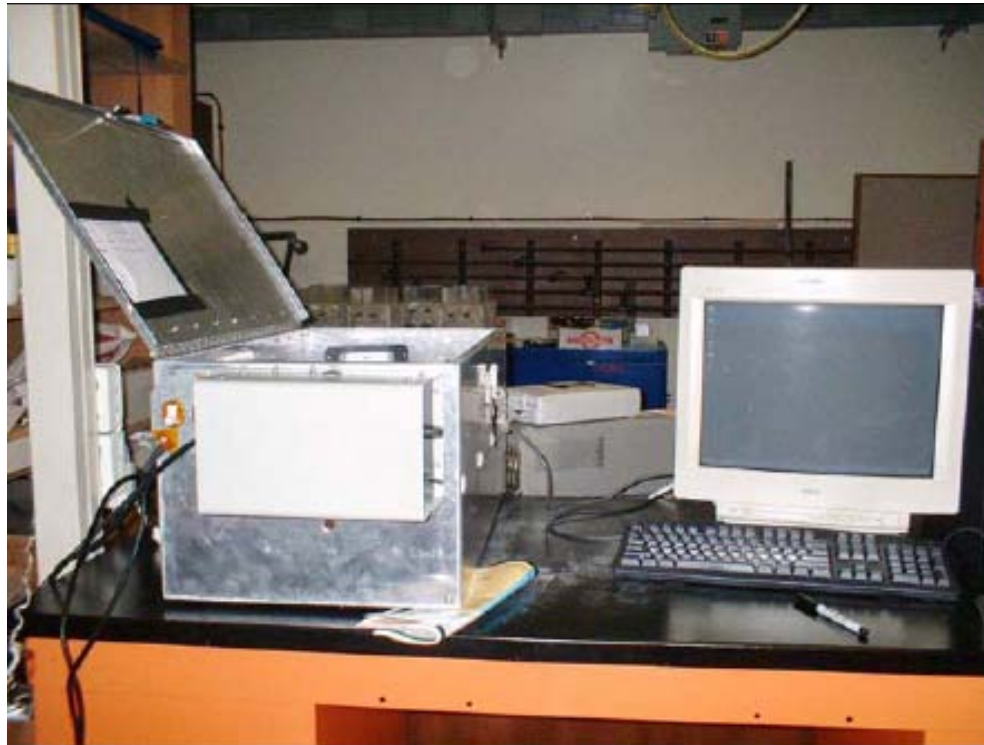
Prototype FCI Paint Scanner and PC

Other components of the test setup included the Fluorescent Corrosion Indicator (FCI) paint scanner system.

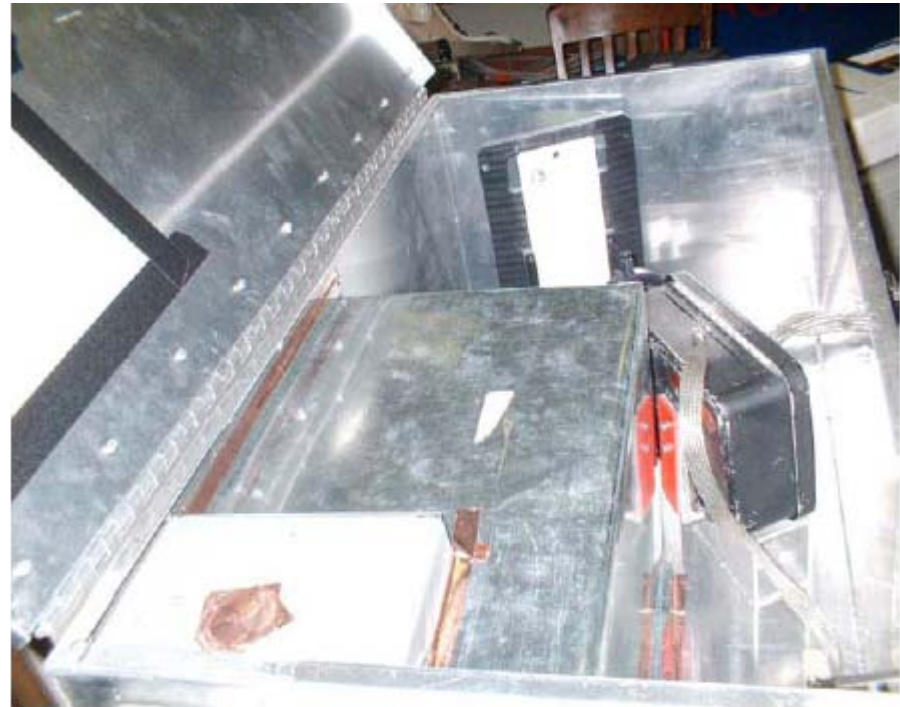
Prototype FCI Paint Scanner Internal View

The paint scanner contained a high-energy UV source for illumination of the paint, a high speed digital camera with a UV blocking filter to record the fluorescent image, and a coupon fixture to hold the coupon under test in the same position for each fluorescent image scan.

The system scanned and recorded an image to detect the change in the fluorescent indicator level as a function of the corrosion beneath the paint.

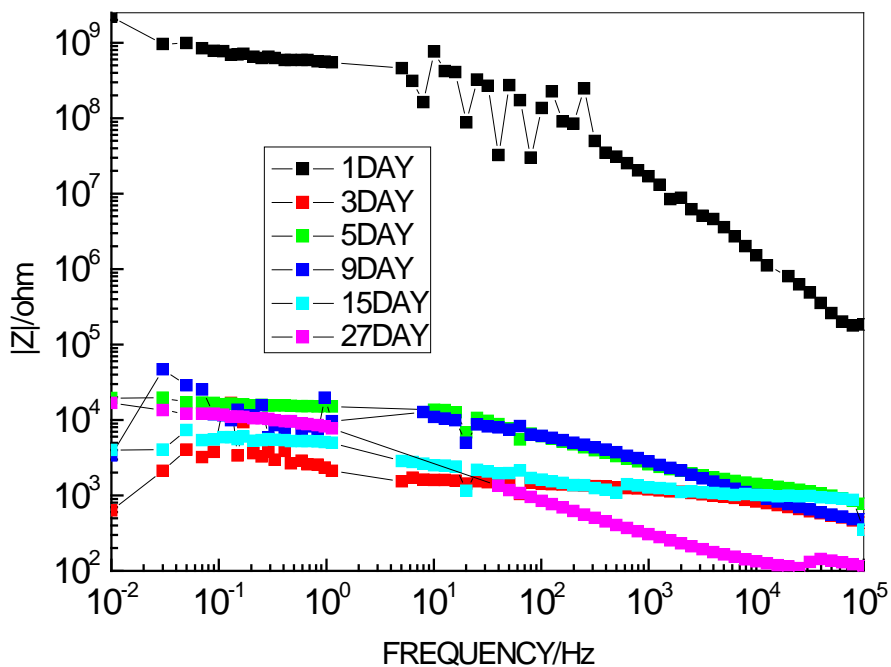
Bode impedance plot for the 2024 aluminum (Metal plus Primer) immersed in 3.5% NaCl

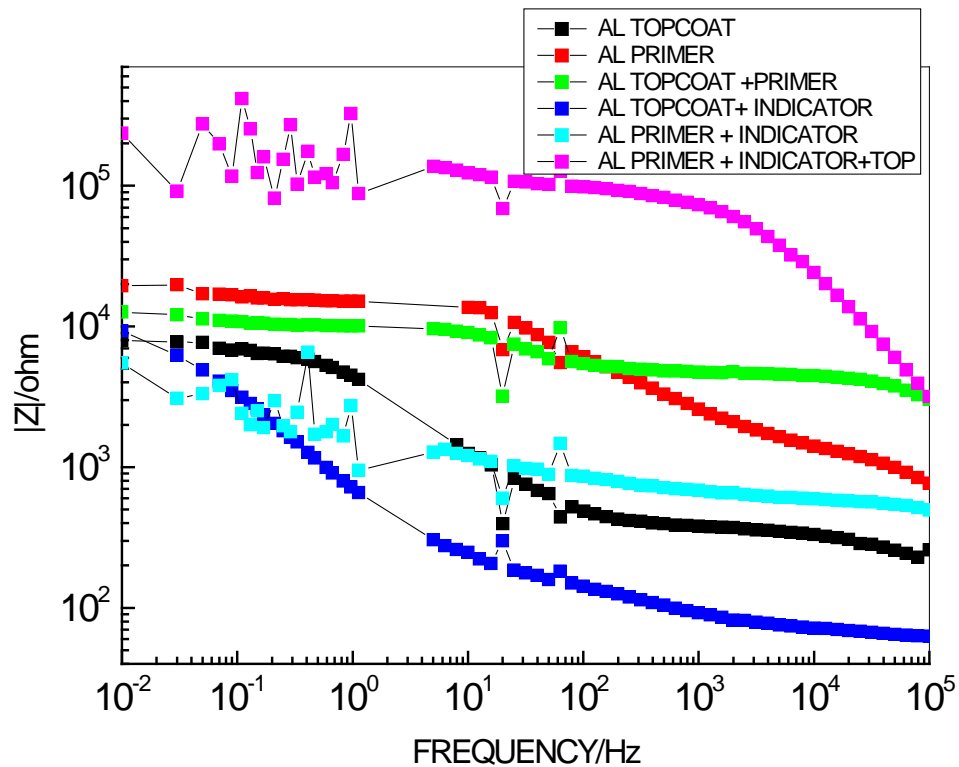
Bode impedance plot of 2024 aluminum with different coating combinations immersed in 3.5% NaCl solution for 5 days

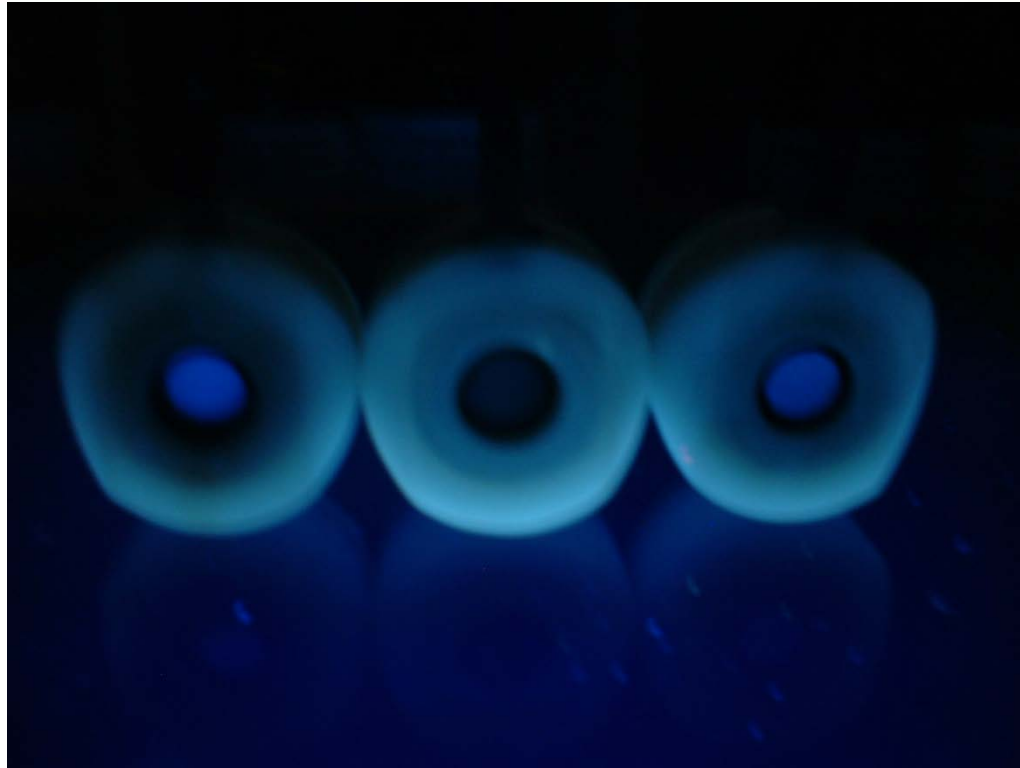
**2024 Al, After corrosion; Center specimen
Contained no indicator**
