Implementation of Inaccessible Corrosion Sensors on Military Aircraft

W.H. Abbott
Battelle- Columbus
OSD Project

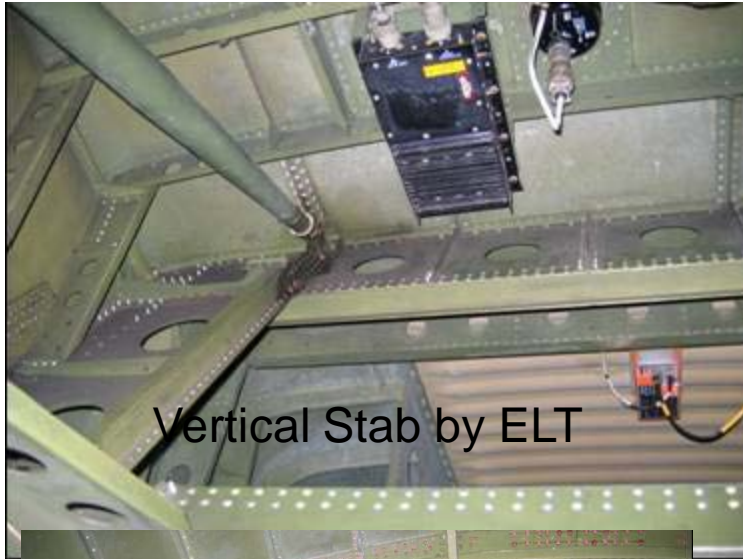
Vertical Stab by ELT

- Limited Data From New C5 Installs (Just starting)
 - 90013 Just Measured WPAFB @ 4 months
 - Large/unexpected “hit” @ Top of T Tail By ELT (Bare sensor only)
 - Skin Corrosion and Paint Loss Evident Visually
- Data Available From 2005 Installs
 - Accessible Sensors
 - With and Without CPCs
- Data Available From F16D Inaccessible Installs (flying since 2003)
- No Data Yet On C130 or H60

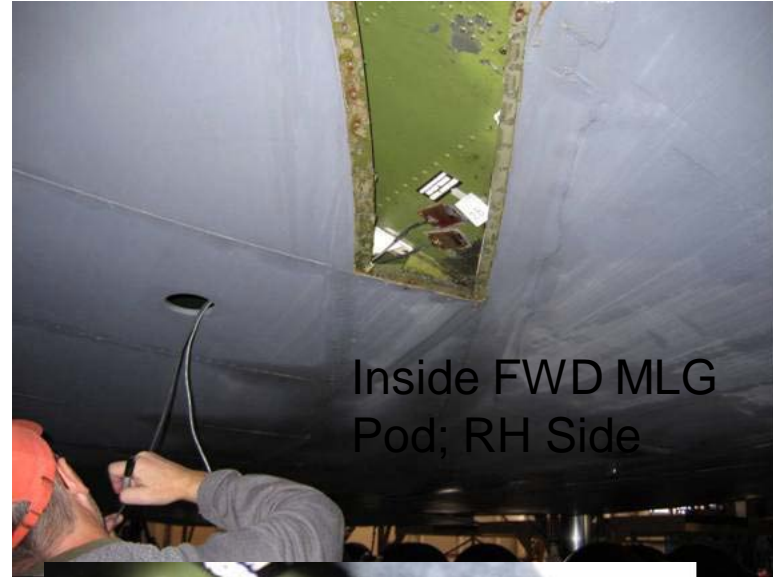
Inside FWD MLG Pod; RH Side

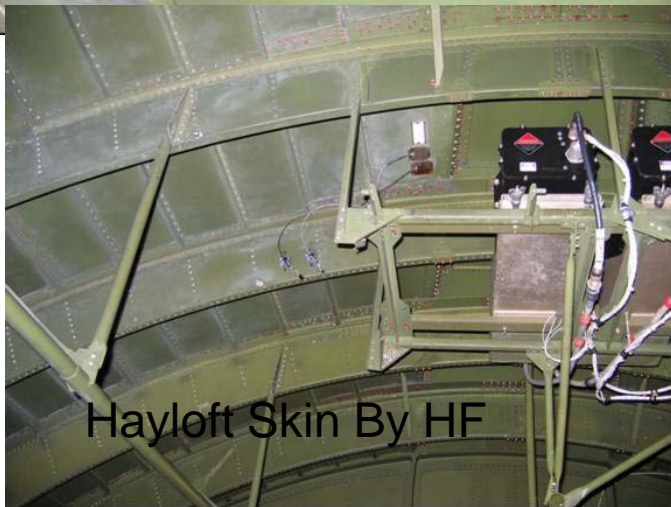
Hayloft Skin By HF

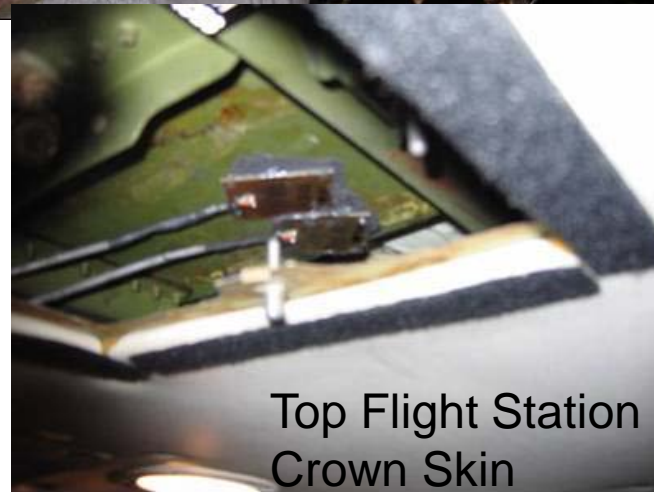
Top Flight Station Crown Skin

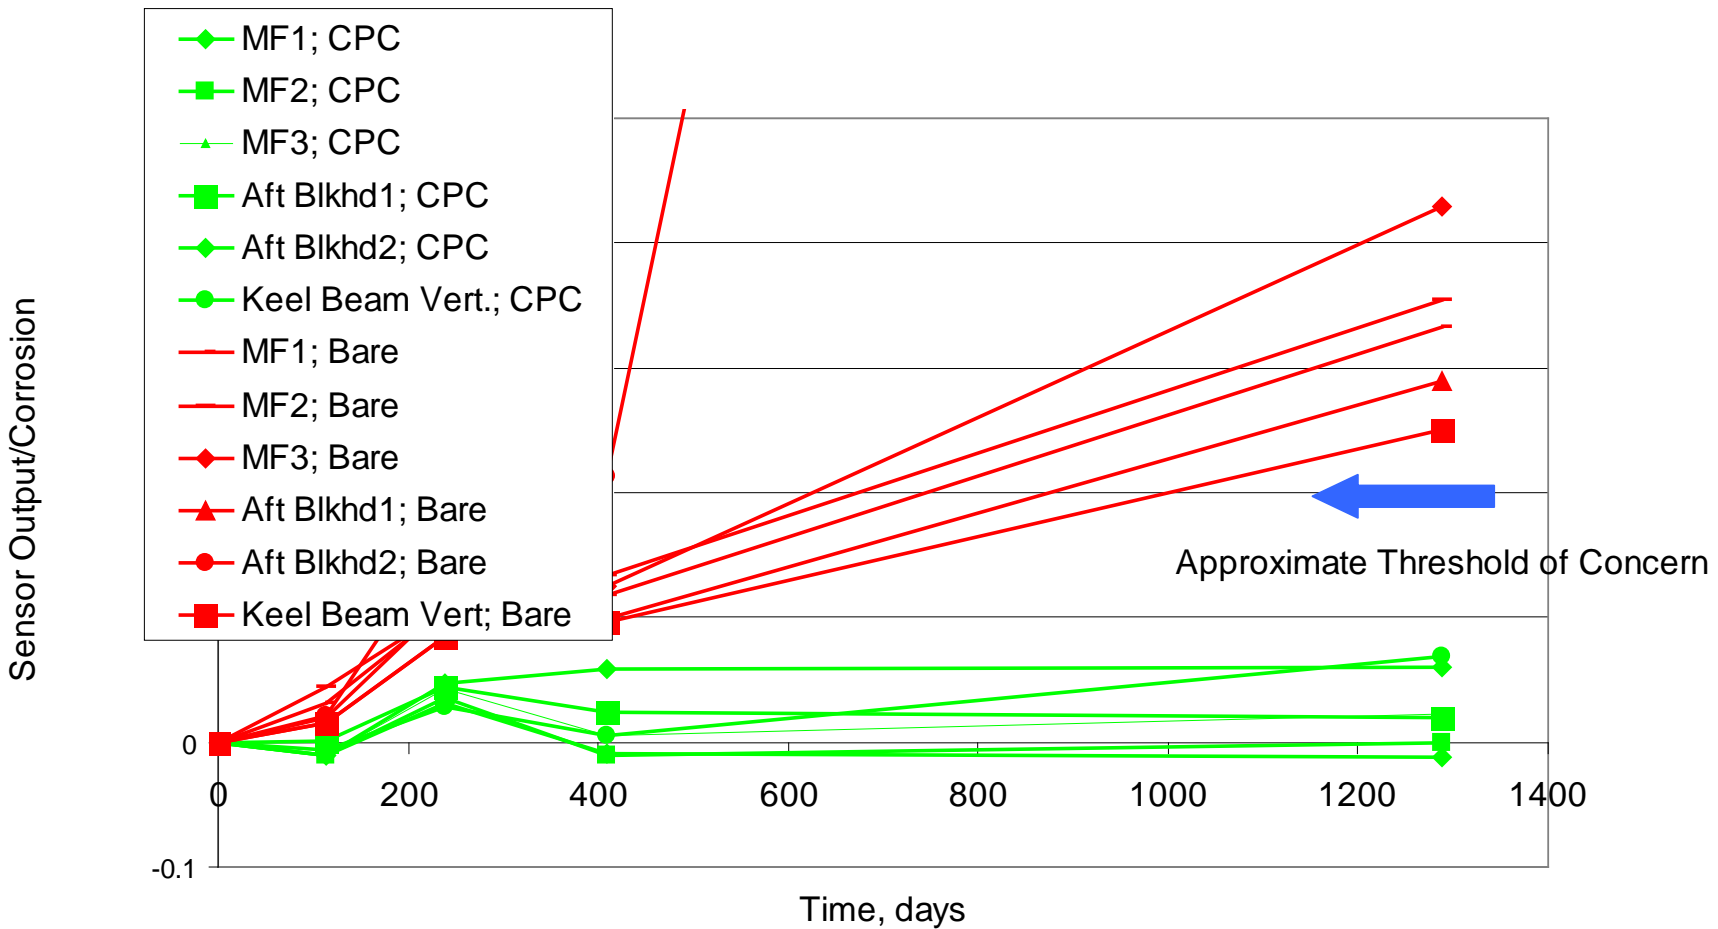
Sensor Kinetics and CPC Benefits On Accessible Sensors

From 2005 Installs; C5 690027

Red= Bare; Green= CB35

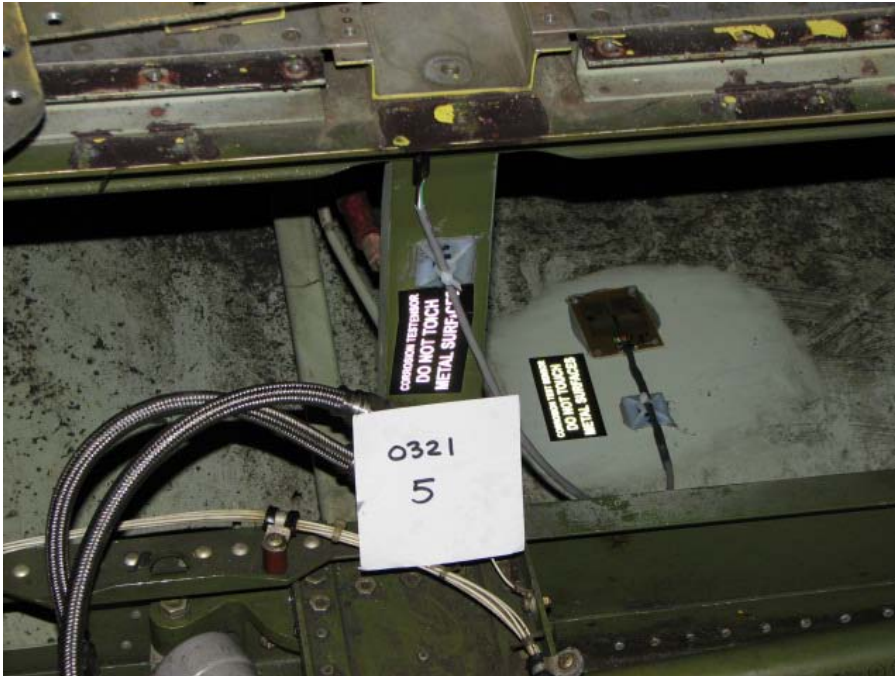
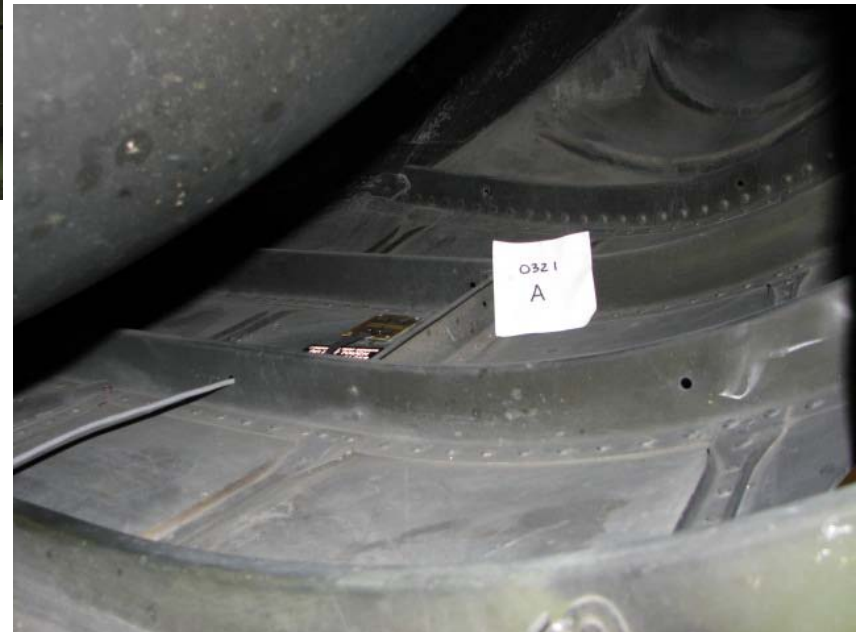
C130 Examples

- 1 Bare Sensor Each Location
- 3 Aircraft; Savannah ANG; 4th planned
- Locations
 - Left Horizontal Stab
 - Right Horizontal Stab
 - Rear Cargo Ramp; Center Fuselage
 - Left Wing to Fuselage Fairing
 - Under floorboards; 2 locations

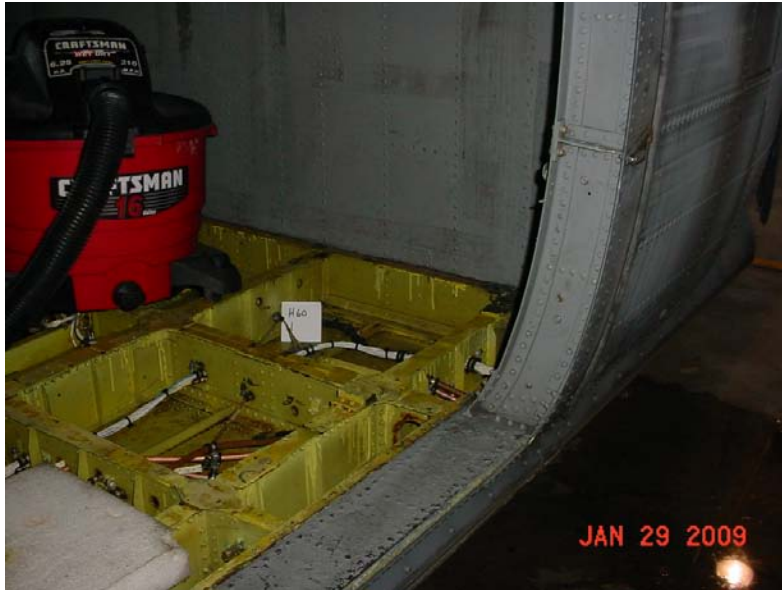
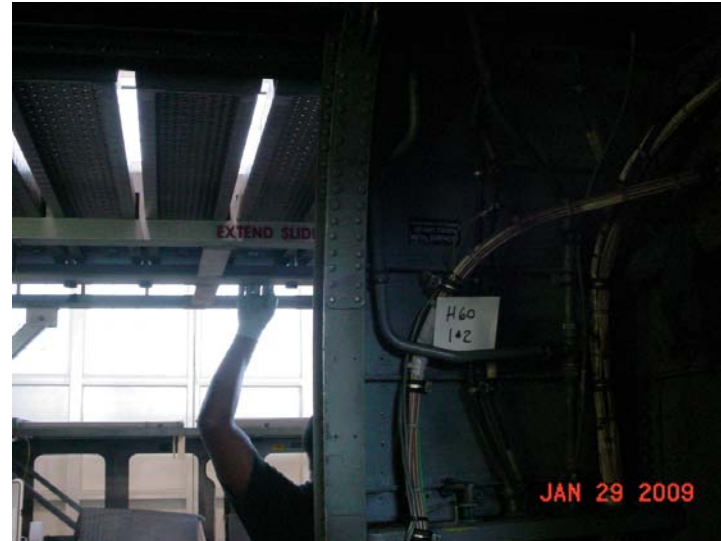
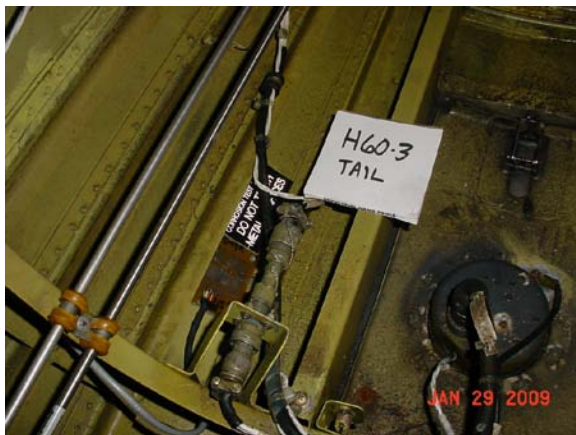
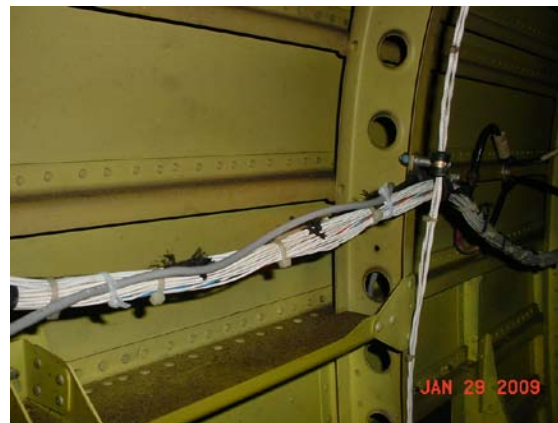
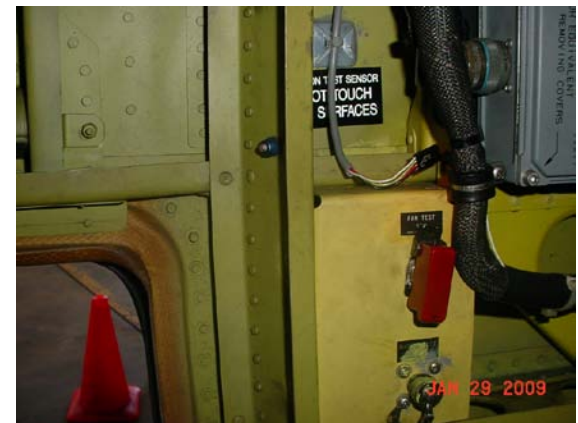
H60 Examples ; Patrick

- Areas of Interest
- First Installations
 - Patrick; Feb 2009; Phase
 - Under Floorboards (2); Tail Boom (1); Fwd Avionics (2)
 - Probably Fogged With CX
- Planned Installations
 - Phase; E City & CCAD
 - Possible Other Bases CONUS and OCONUS @ Phase
 - Timing Critical To Coordinate With Floorboard and INU Removal

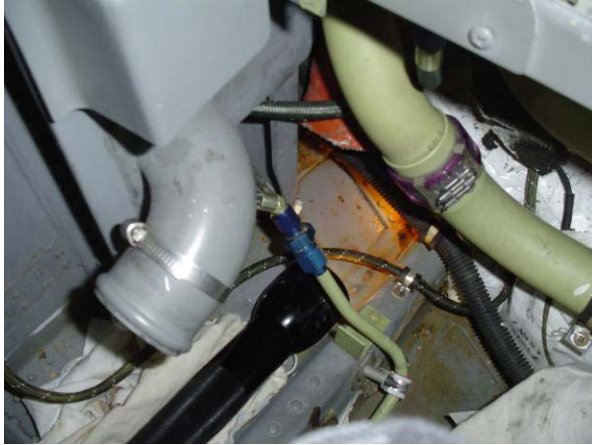
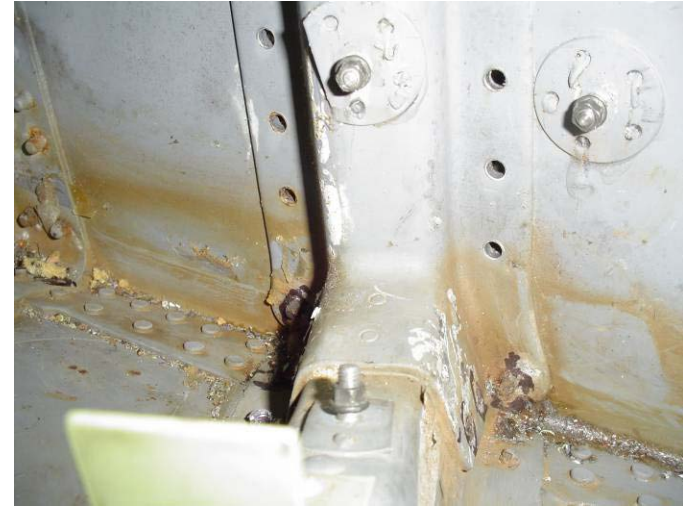
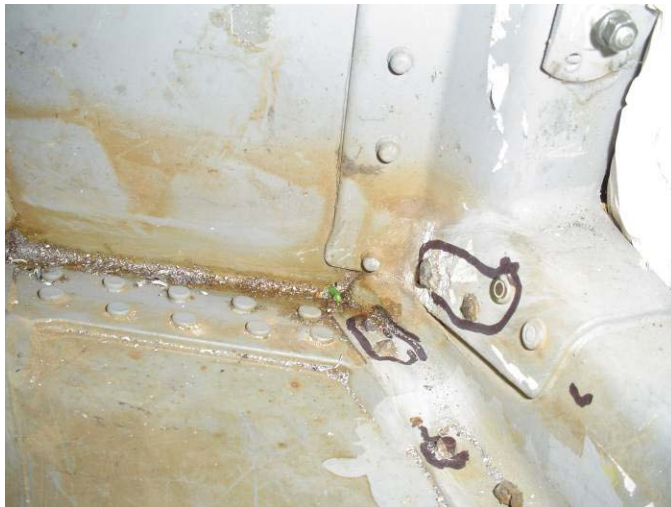
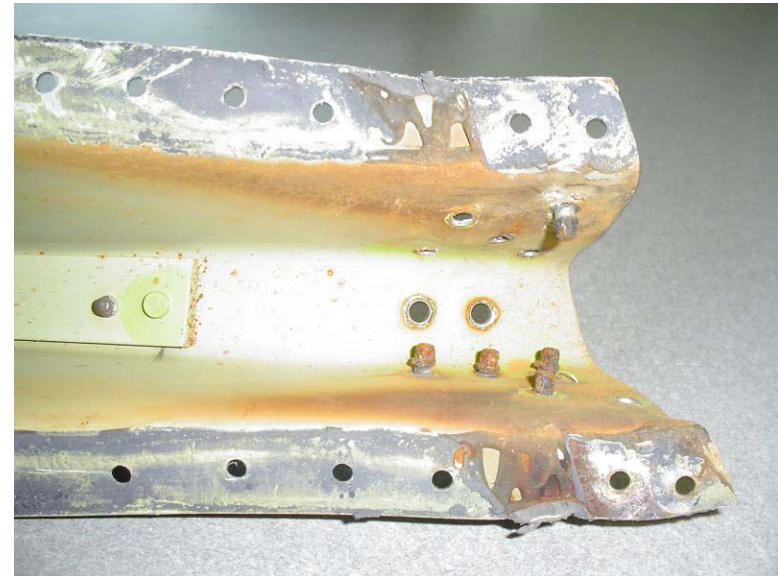
Corrosion Under Rear Seat Of D's

Corrosion Examples A/C 382; Under Rear Seat

- Serious Long Term Corrosion/Safety of Flight Problem
- Source(s) of Problem and “Fix” Uncertain
 - ECS Malfunction ?
 - Other Water Intrusion
 - Microbial ?
 - Wet Insulation (Similar to C5 Chain Box ?)
 - **Unpredictable By T/N**
 - **Possibly >25% of D’s**
- Sensors Being Used For
 - Early Warning
 - Inspection Tool
 - Targeted Seat Removal
 - Hard Metrics For Possible Mitigation
 - Insulation Removal
 - CPC Use
 - Springfield, Lackland, Homestead, McEntire, Edwards

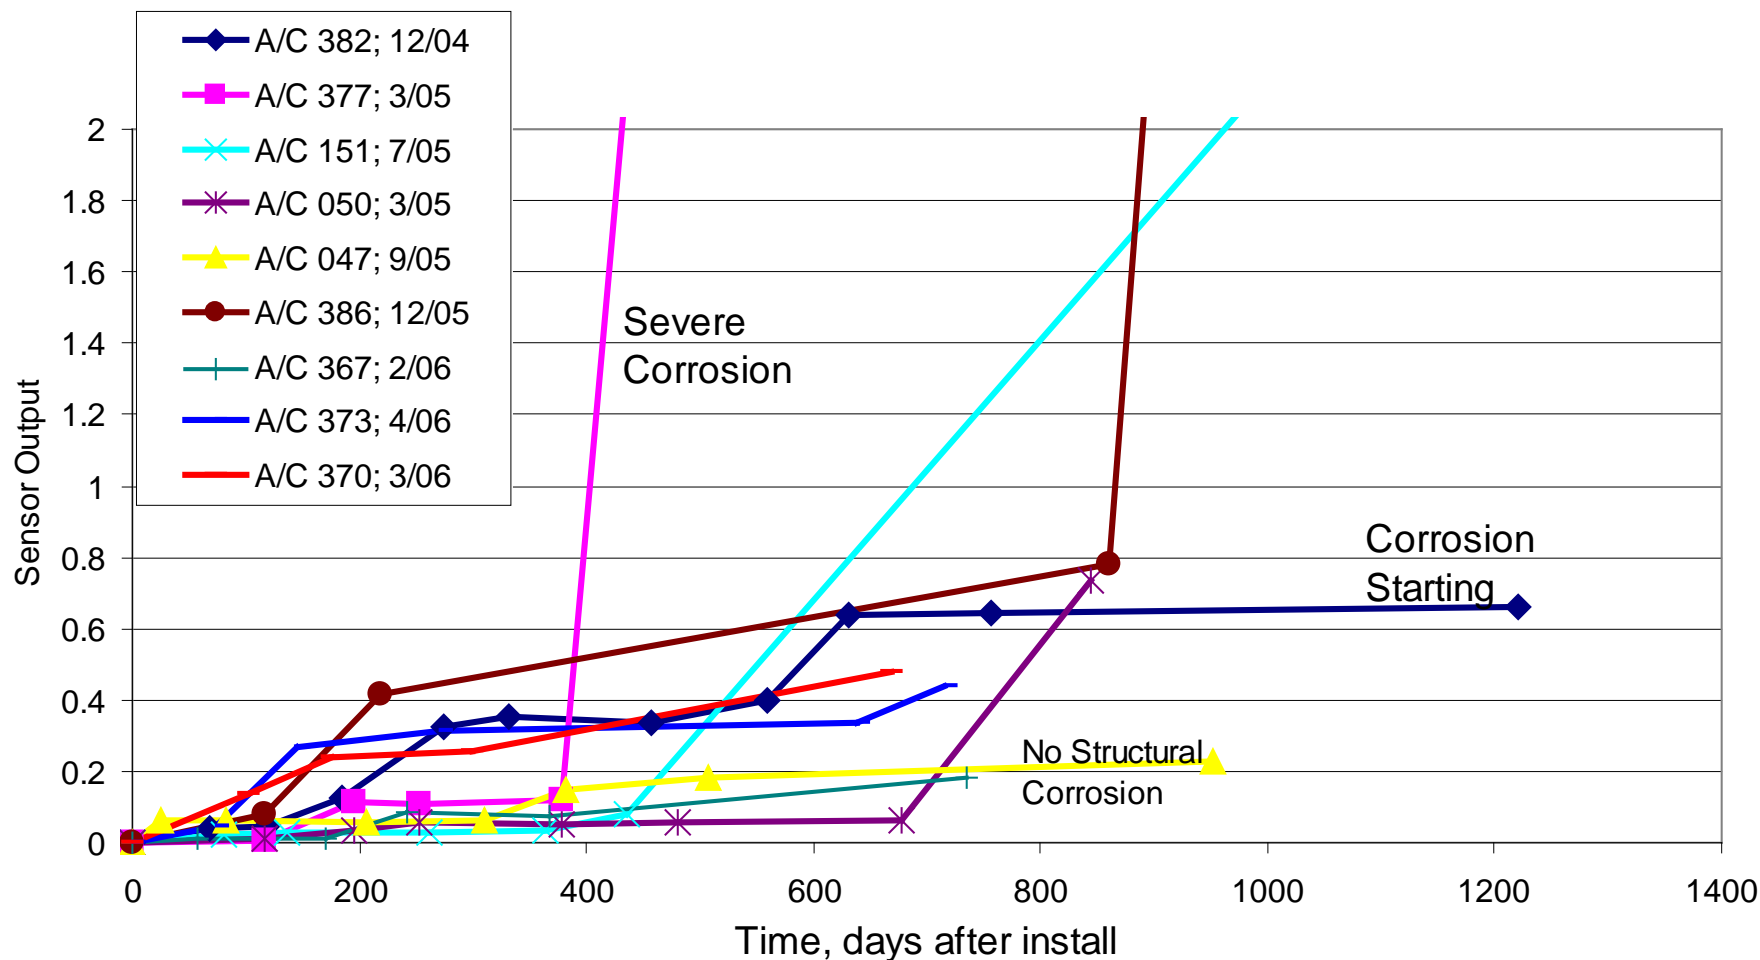
Typical Sensor Output Data By T/N; F16 D; WAAR
