Contamination Survey of Deployed Aircraft Avionics

David H. Johnson¹, Paco Solis² and Douglas C.
Hansen³

Air Force Corrosion Conference
Perry GA
24 -26 March 2009

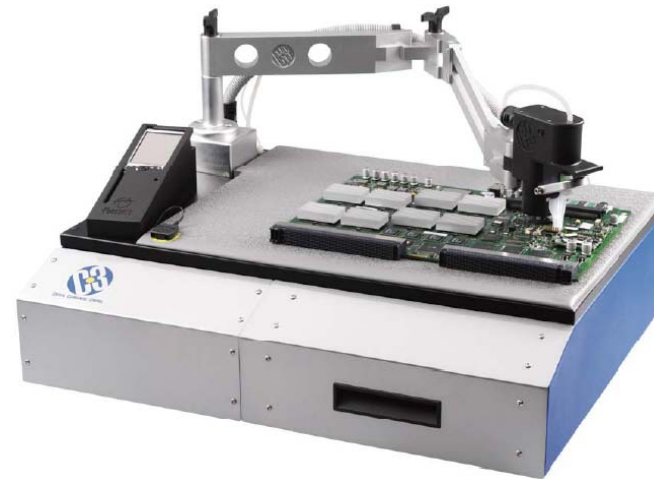
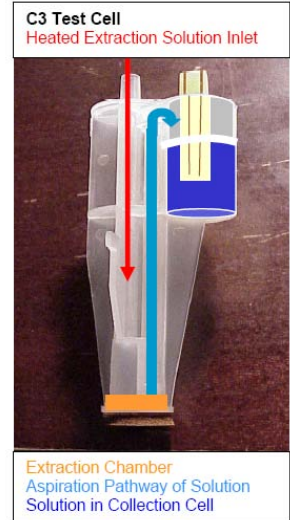
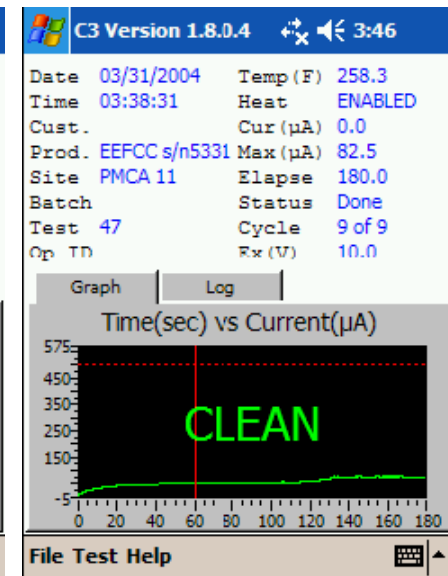
C3 Tester System

- Deionized steam delivered to sample site (0.1 in²);
- Extraction of soluble ions;
- Aspiration of solution into collection cell;
- Cycle repeated 9 times;
 - Total time: 3 minutes
- Y-pattern electrode used to measure leakage current in cell solution (10 V bias);
- Current threshold of 500 μ A set ;
 - Based on SIR and chromatography data
 - Time limit of 60 seconds for threshold limit
 - Total time: 3 minutes
- Cell solution analyzed off site using ion chromatography
