# **B-52H Corrosion Prevention Plan**

**2009 Air Force Corrosion Conference**

**B-52 Fleet Support**

**26 Mar 2009**

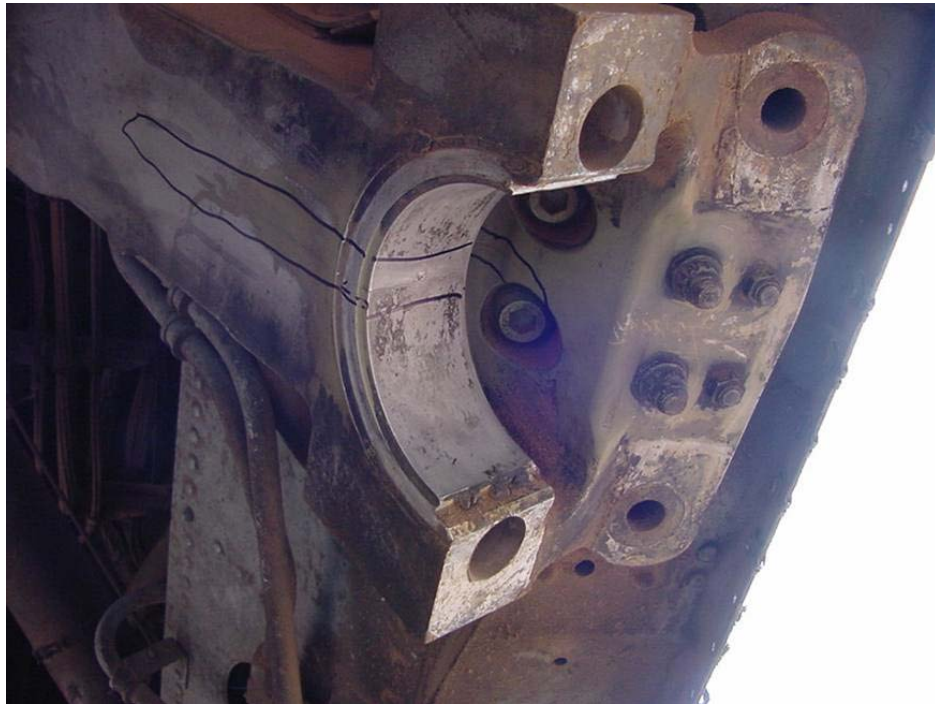
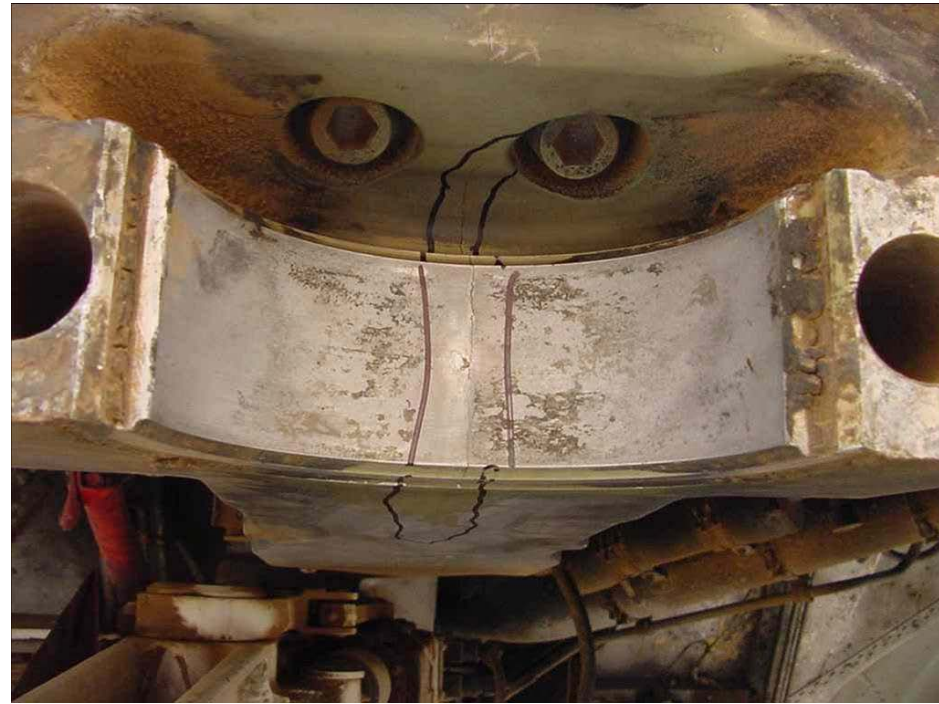
- Parting Plane Crack, B-52G A/C

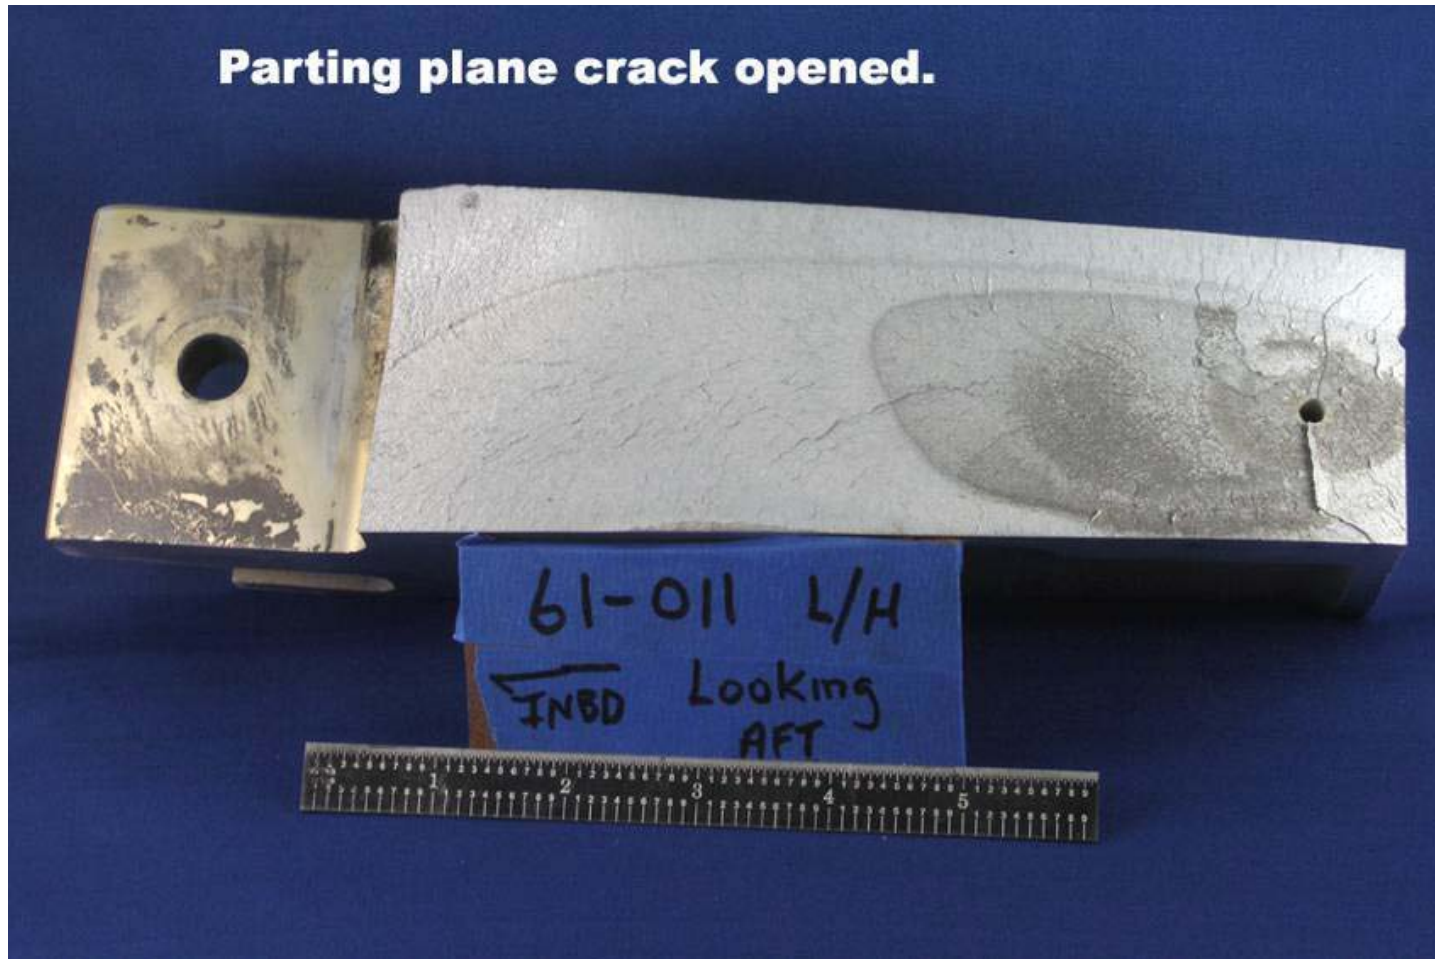
- Parting Plane Crack Opened, B-52H A/C

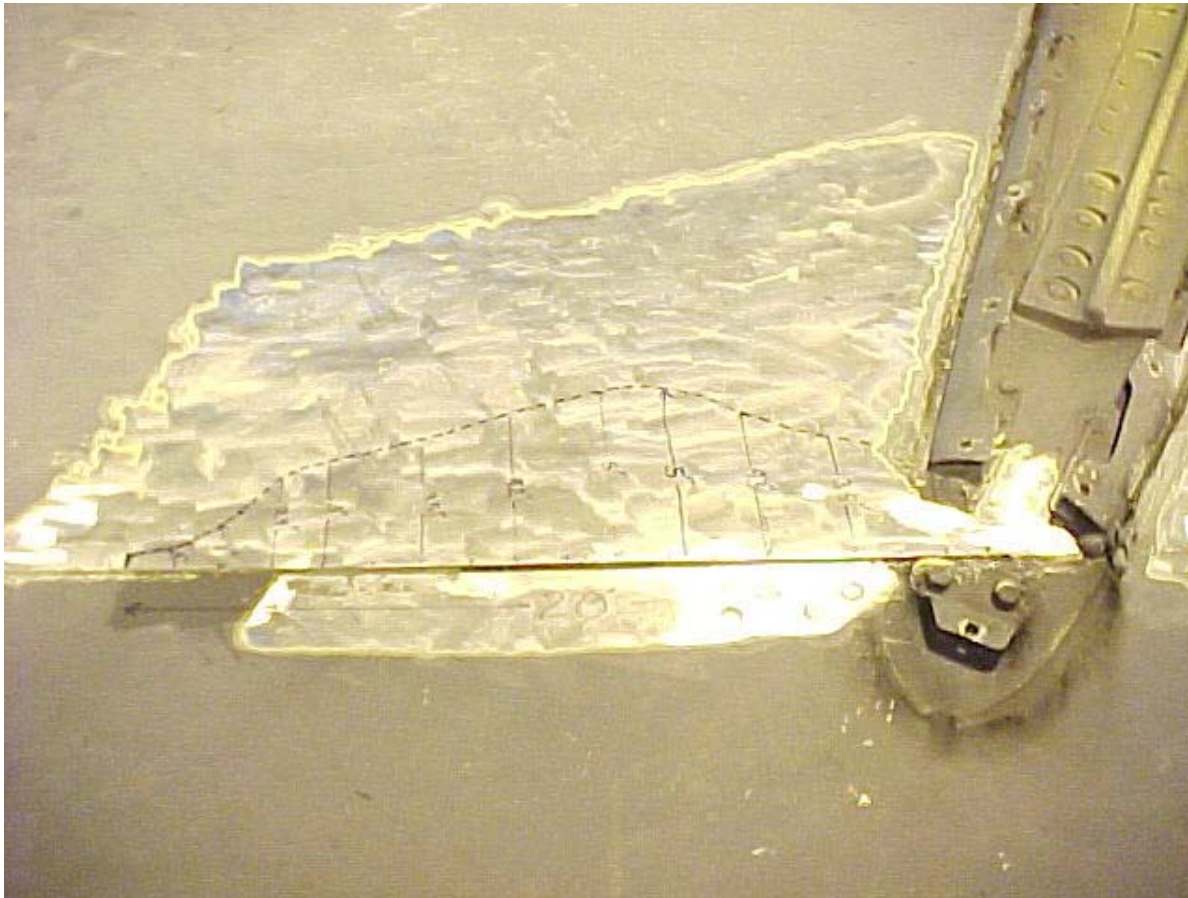
- Laminar SCC, B-52H A/C

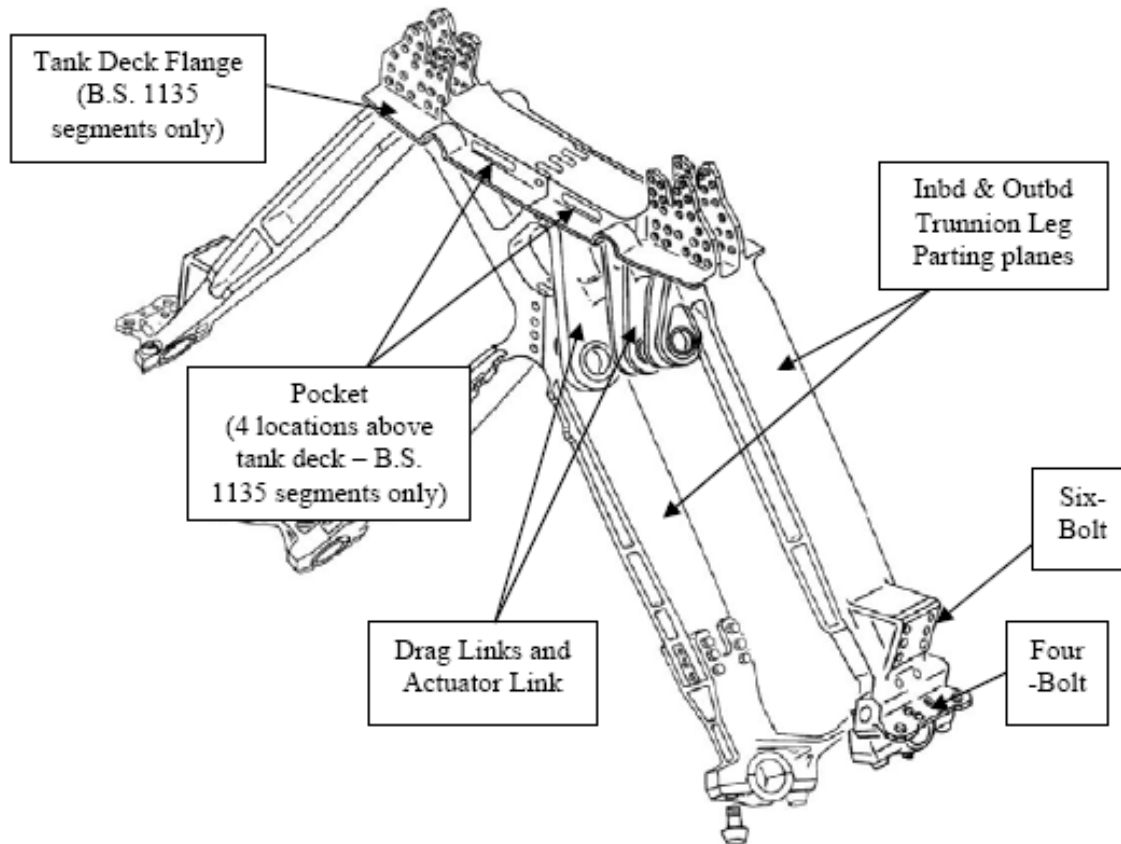
- MLG SCC Cracking

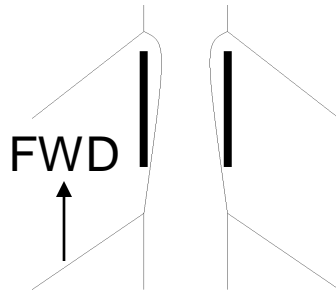
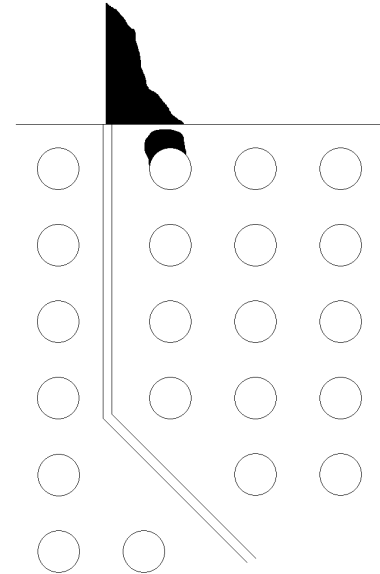
- Upper BBL 55 Splice Corrosion & SCC

Splice Plate

Wing Skin

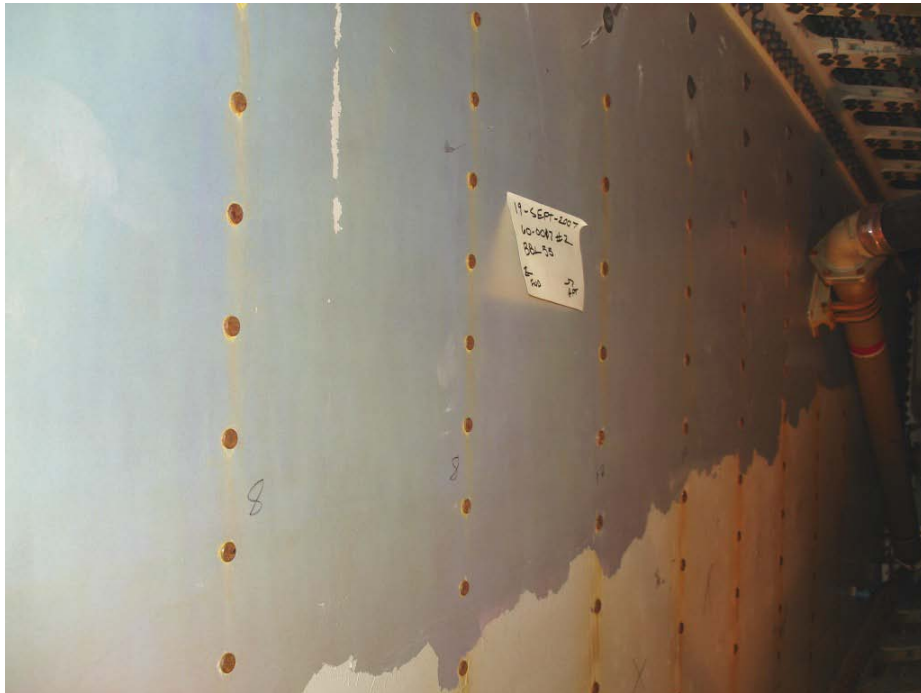
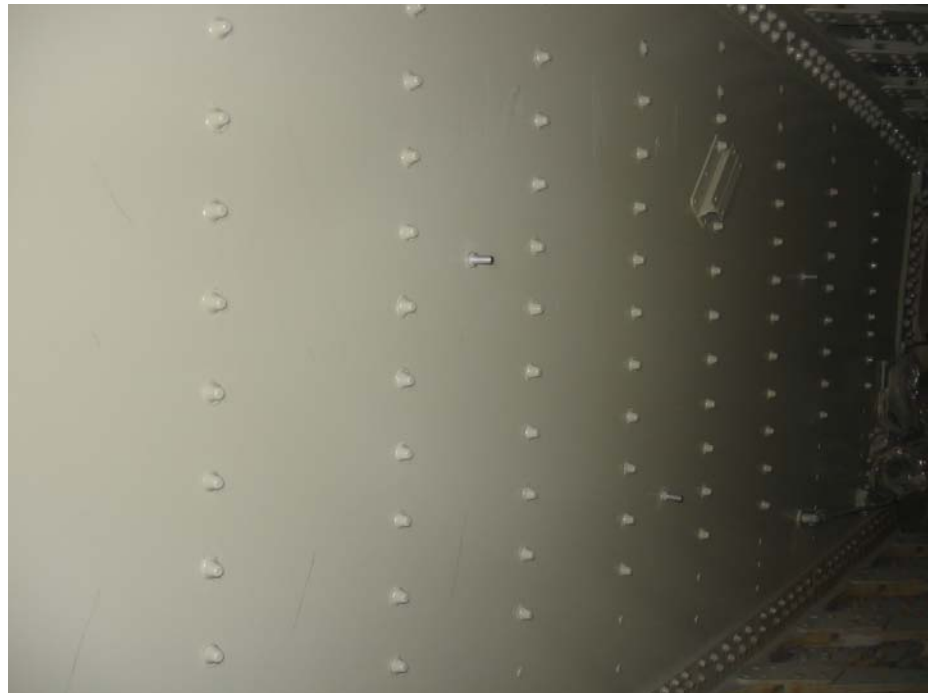
- BBL 55 Rib Web, 7178-T6 Plate

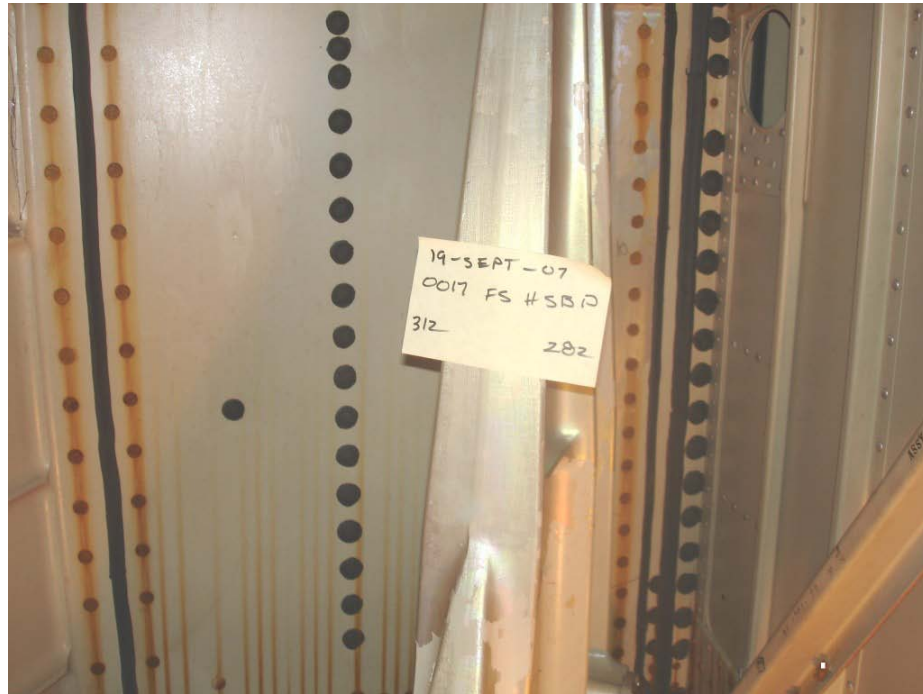
- Heavy Stores Adaptor Beam Attachment Fitting, 7079-T6 DF
