# Organic Finishing Technologies

## B-52 Paint Life Cycle Extension

**Steve Finley, CTC**  
**Support Contractor to**  
**Mr. Tom Naguy**  
**Air Force Research Laboratory**

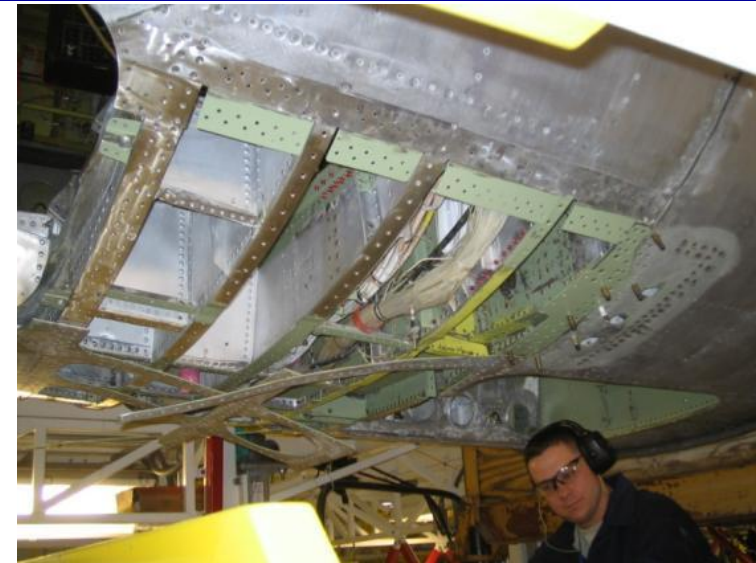
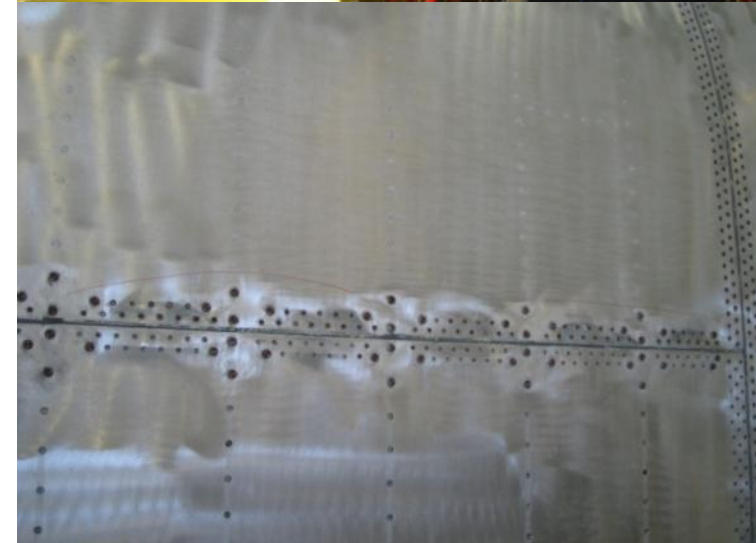
- **X-Ray Photoelectron Spectroscopy**
  - Cr+6 levels in samples were equal to samples taken from freshly applied primer
  - Indicates still enough Cr+6 to provide corrosion protection
- **Conclusions from Laboratory Testing**
  - Coating system next to substrate was nine years old; still had substantial Cr+6 levels
  - Variance in cross hatch and PATTI indicate it was time to paint the aircraft
  - Flexibility of the coating is still adequate

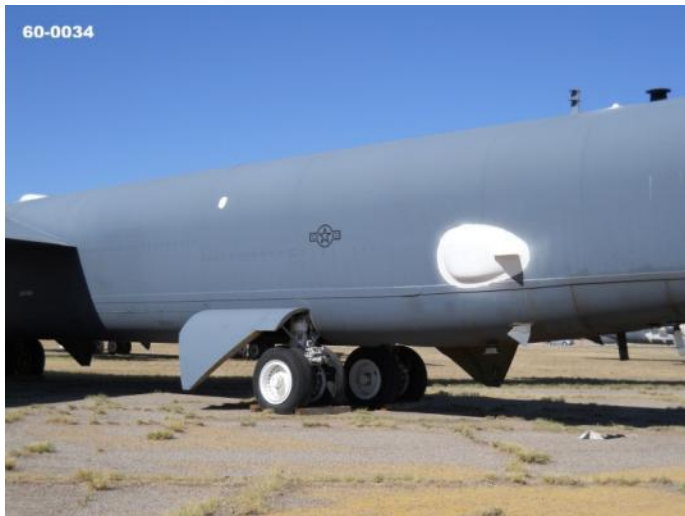
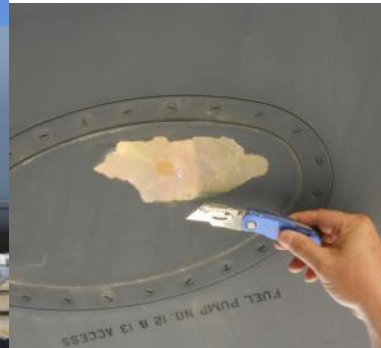
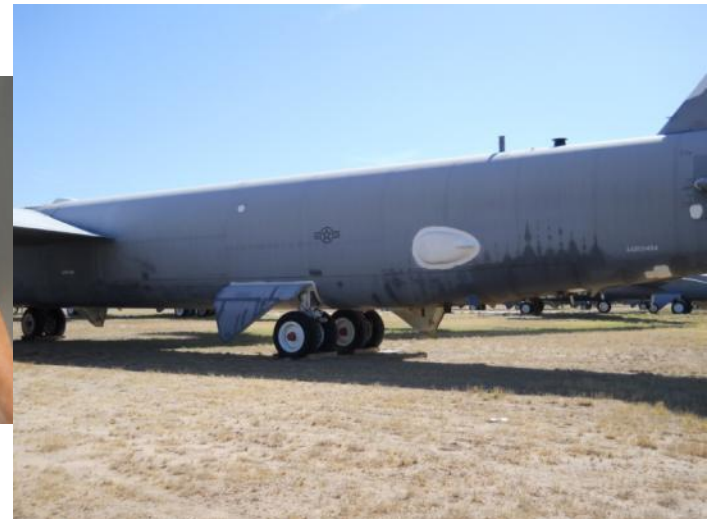
- One adhesion failure noted on the inboard fuel access panel on the bottom of the right wing aircraft 60-0014
- Aircraft from Barksdale showed higher degree of coating degradation
- Minot aircraft showed little signs of degradation
- No corrosion noted on any of the aircraft observed
