Ground and Flight Testing of Non-Chrome Paint Systems; Part 2– Evaluation of Paint Systems

Battelle-Columbus

Air Force Corrosion Managers Conference

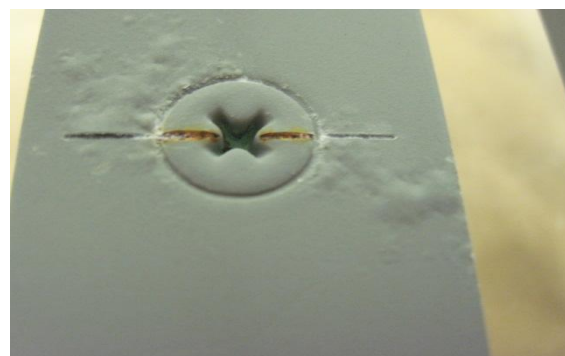
Galvanic Sample; 1 Year; Ground

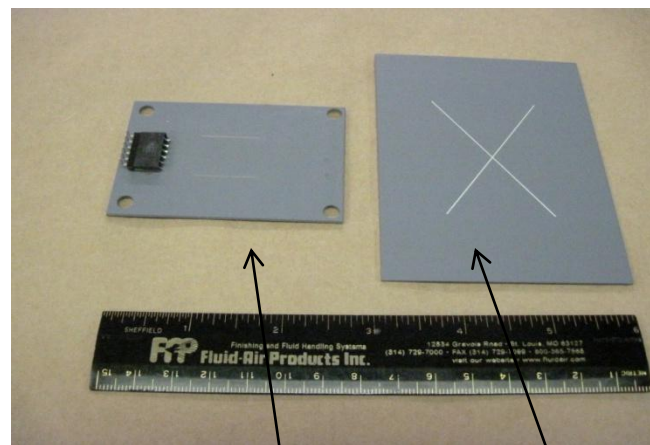
Quantitative/
Objective

Visual/
Subjective

Typical sensor and Panel

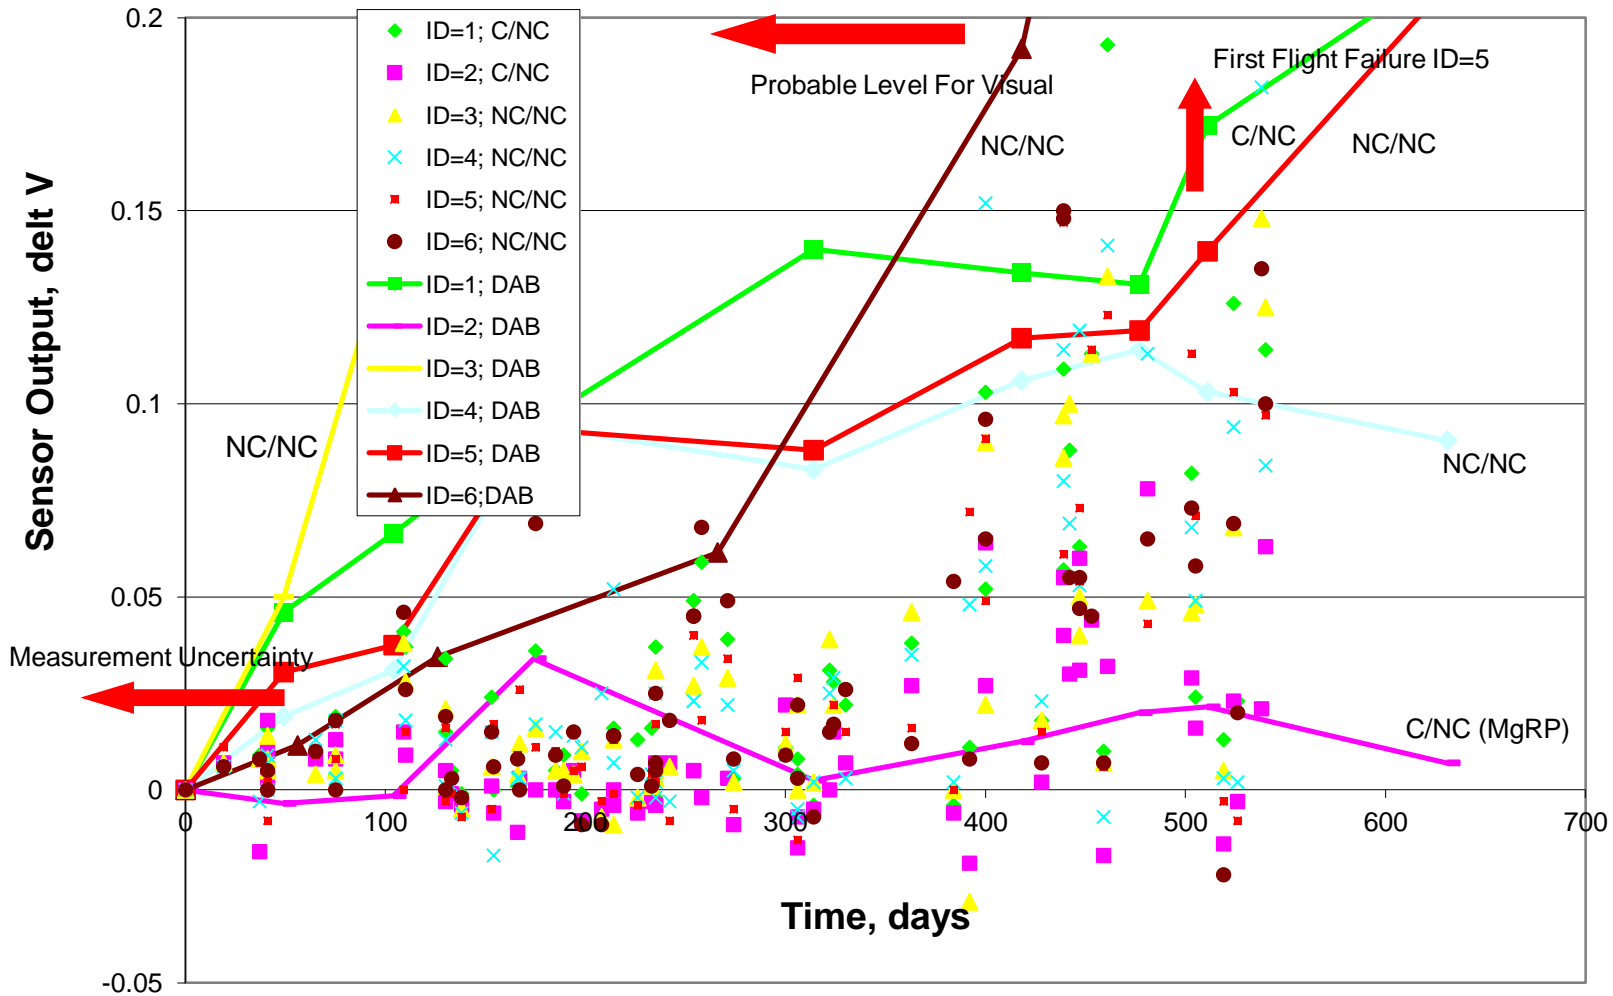
Combined Data For Ground and On-Aircraft (Solid Lines = Ground; Points=Flight By T/N)

- Good Performance Time, Flying
 - Prekote/AE 2100/AE5000 (NC/NC) 4+
 - Alodine 5700/16708 TEP/99GY001 (NC/NC) 1.5
 - Alumigold/AE2100/ 99GY001 (C/NC) 1.5
 - Prekote/02GY040/Desothane HS (NC/C) 1.5
 - Prekote/02GY040/AE5000 (NC/C) 1.5

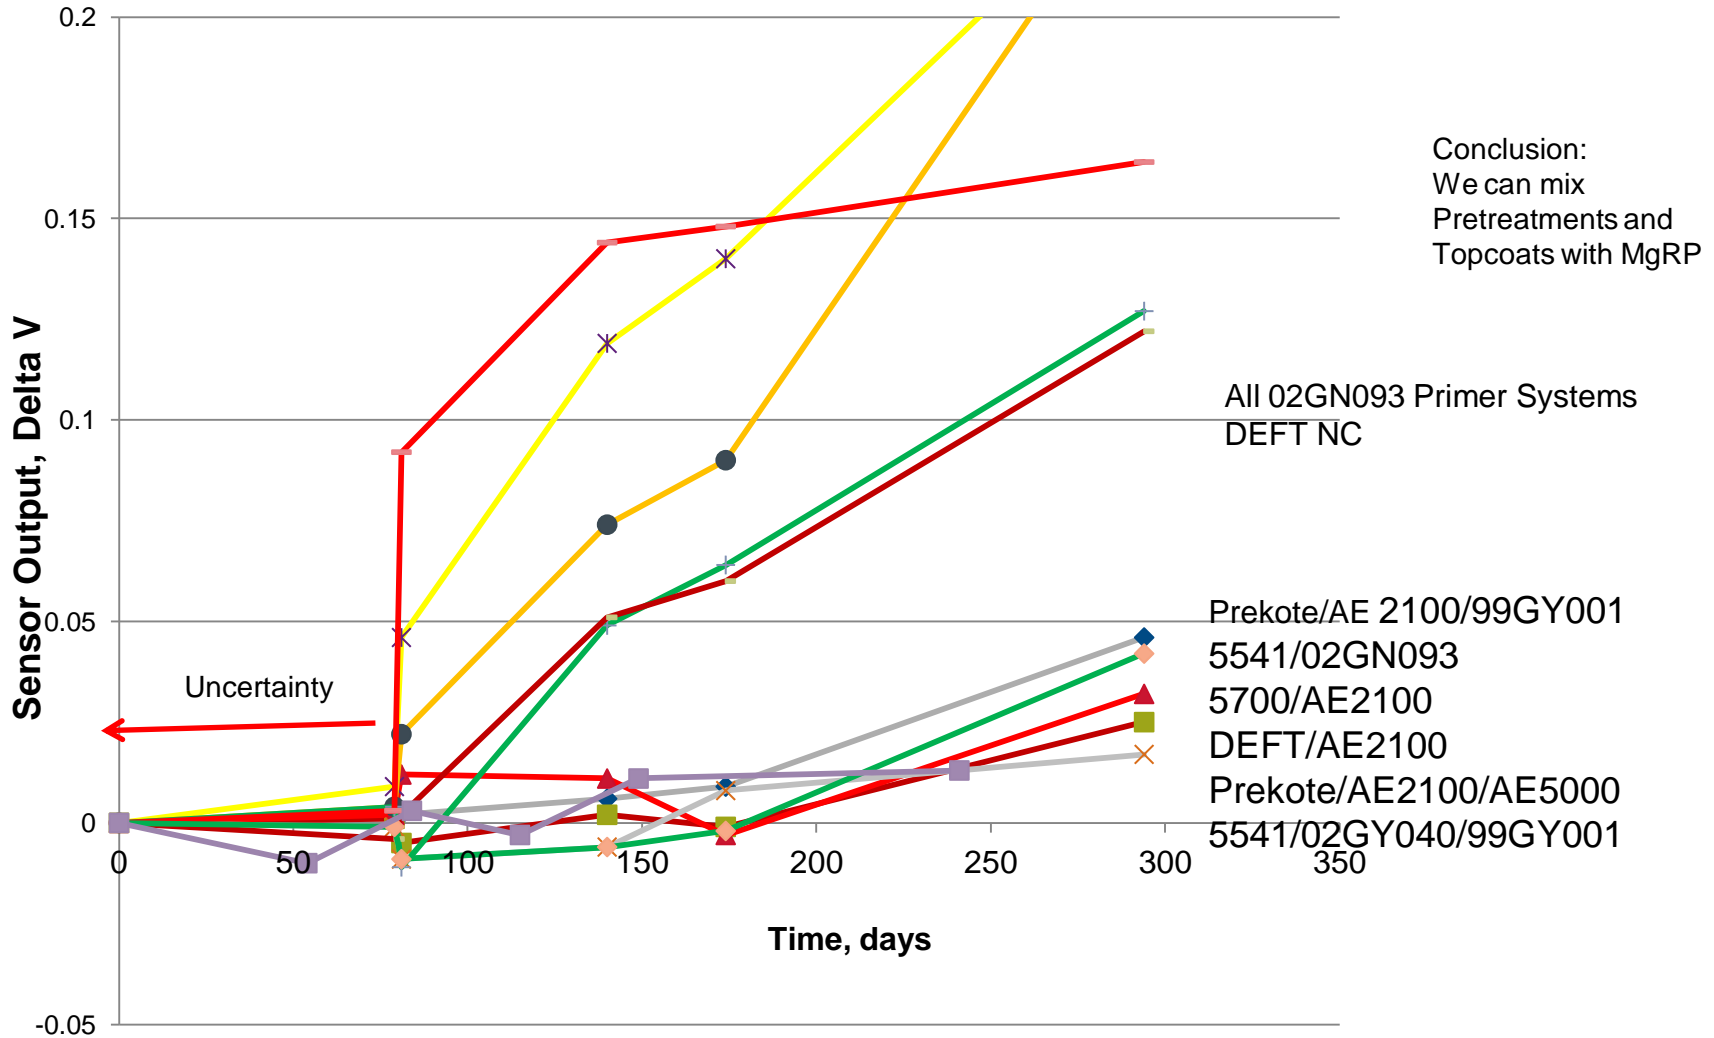
Effects of Pretreatments and Topcoats on Performance of MgRP and Comparisons To 02GN093 Primer; Daytona Ground Data

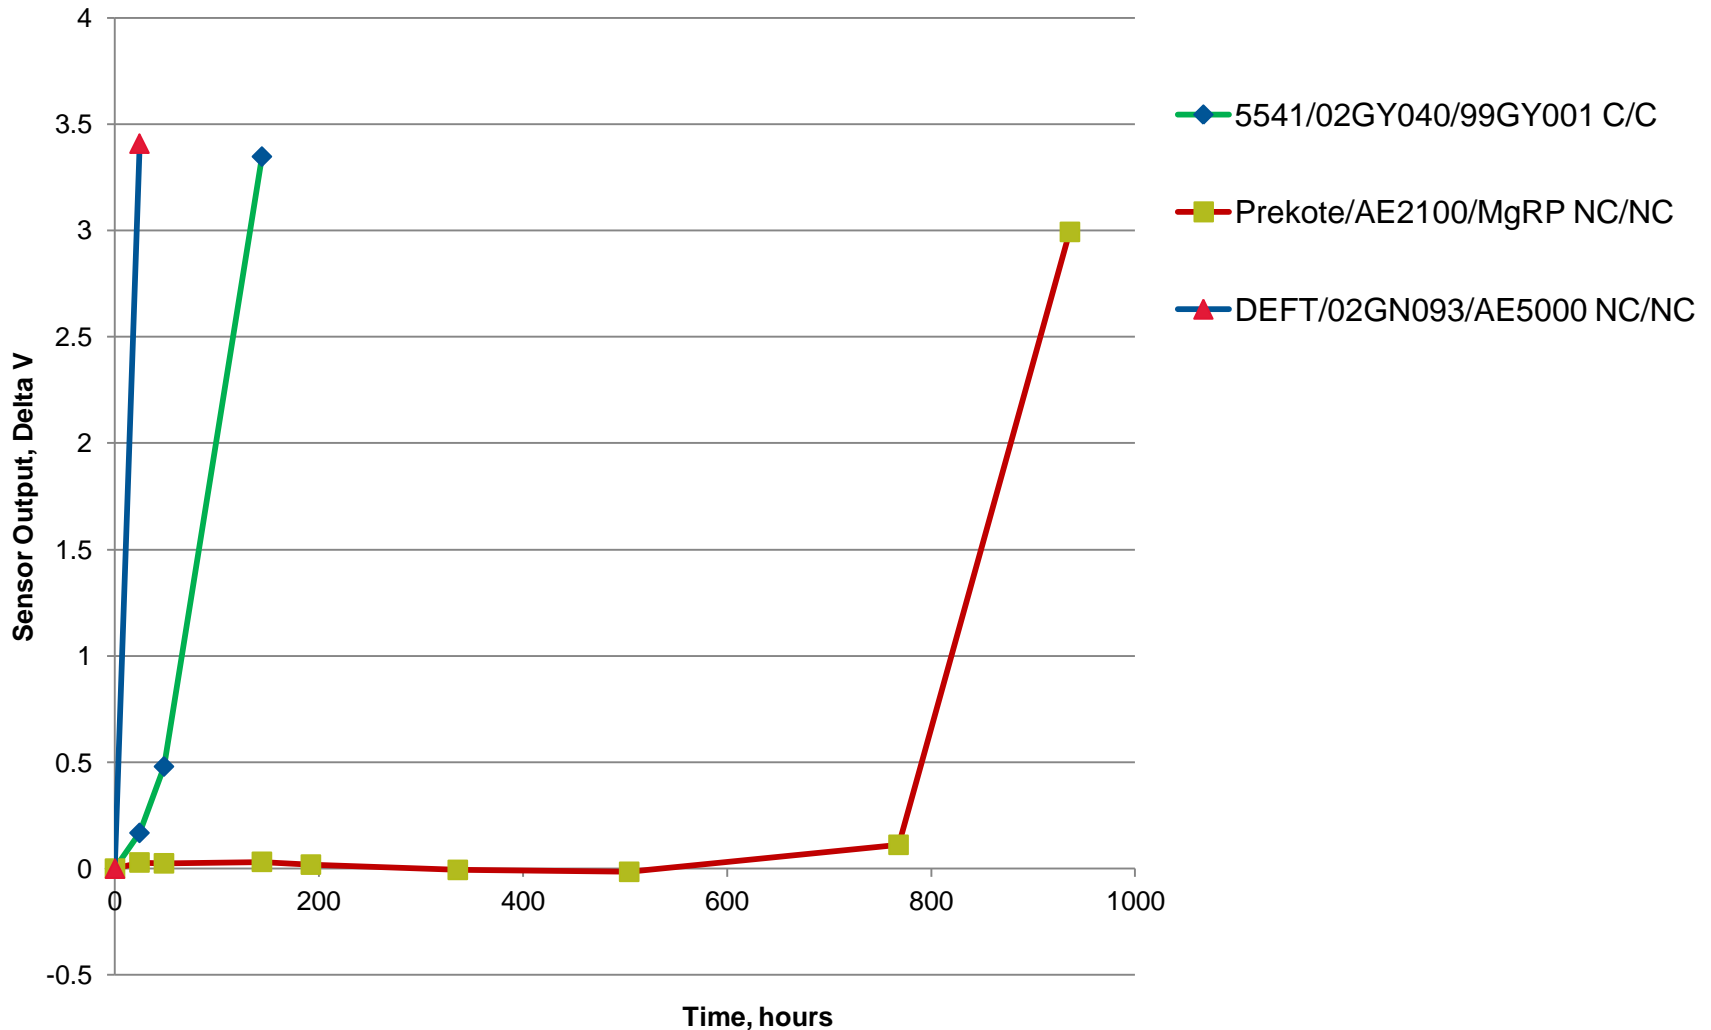
Effects of Urine on Corrosion Sensor Response For 3 Painted and Scribed Coatings; 30 C; 85% rh

- The Threats From Other Chemical Stresses Are Real and Must Be Considered In Paint Evaluations
- One NC/NC System Has Shown Exceptional Resistance
- The Following Slides Show 3 Stress Examples
 - Urine – Bilges; Cockpits
 - Decon Solutions – General Use
 - Fungal Influenced Corrosion – IML; OML (TBD)

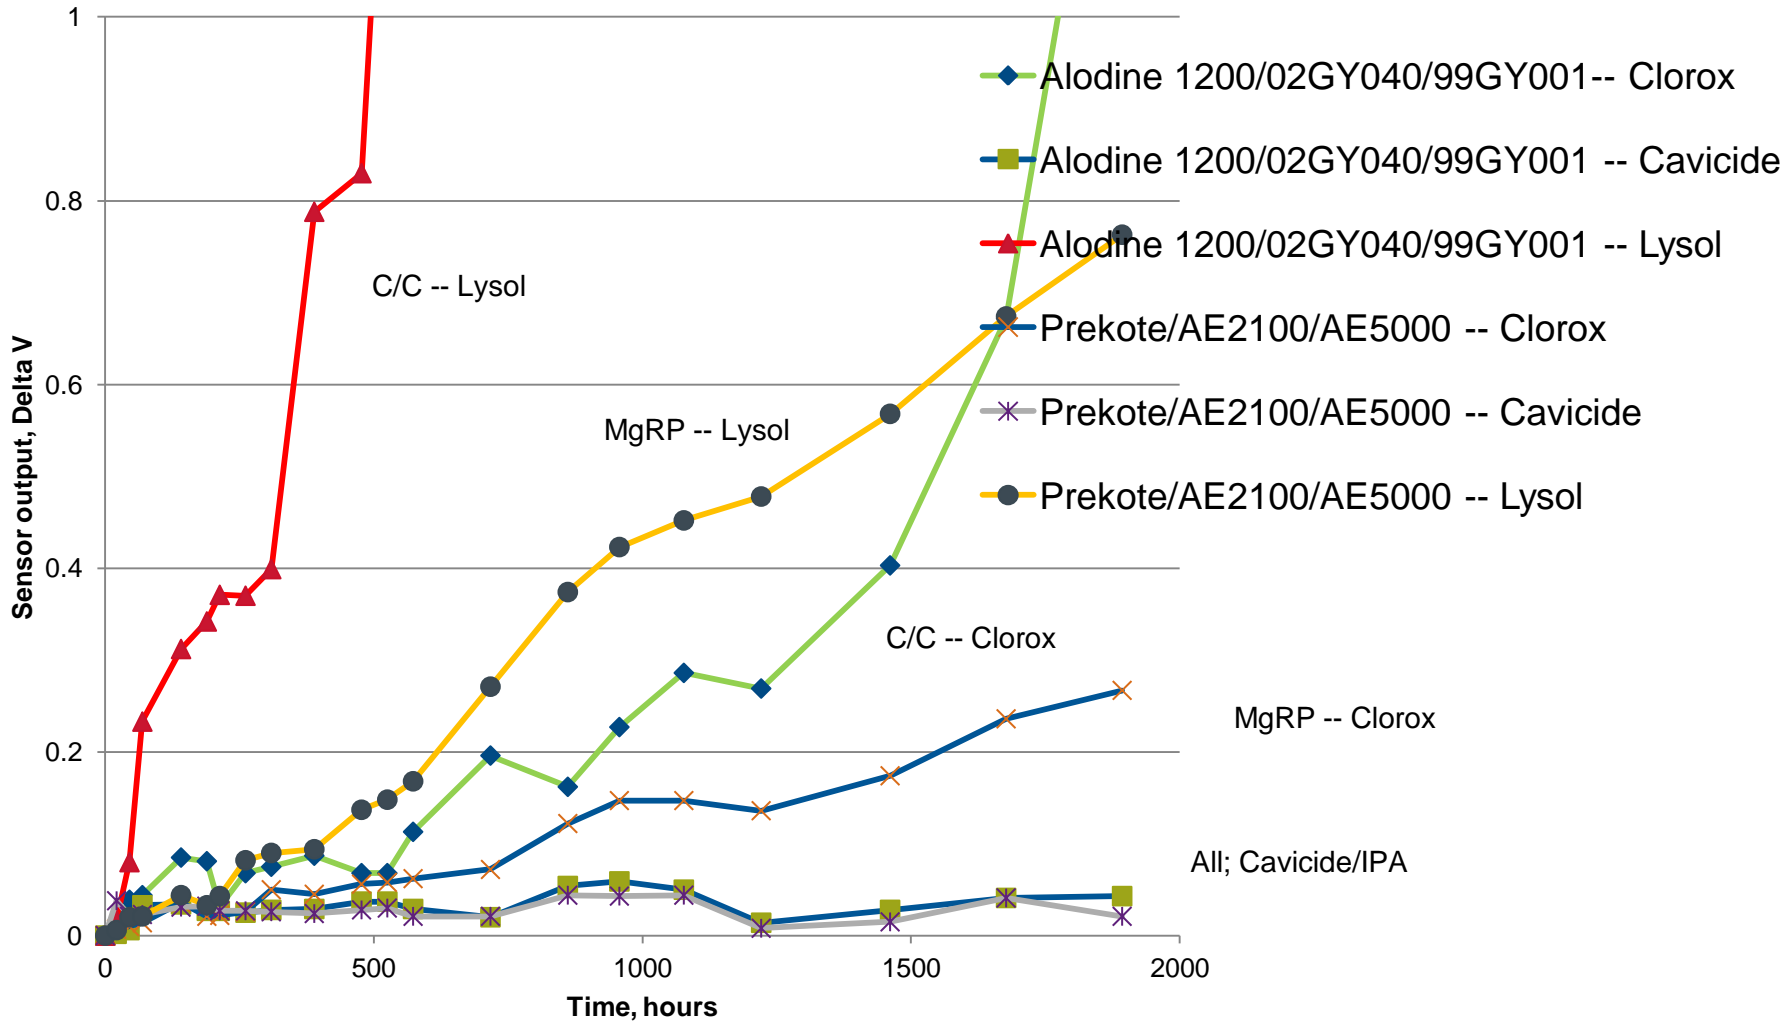
Effects of Disinfectants on Painted and Scribed Corrosion Sensors; 30 C, 85% rh; No Rinse Series

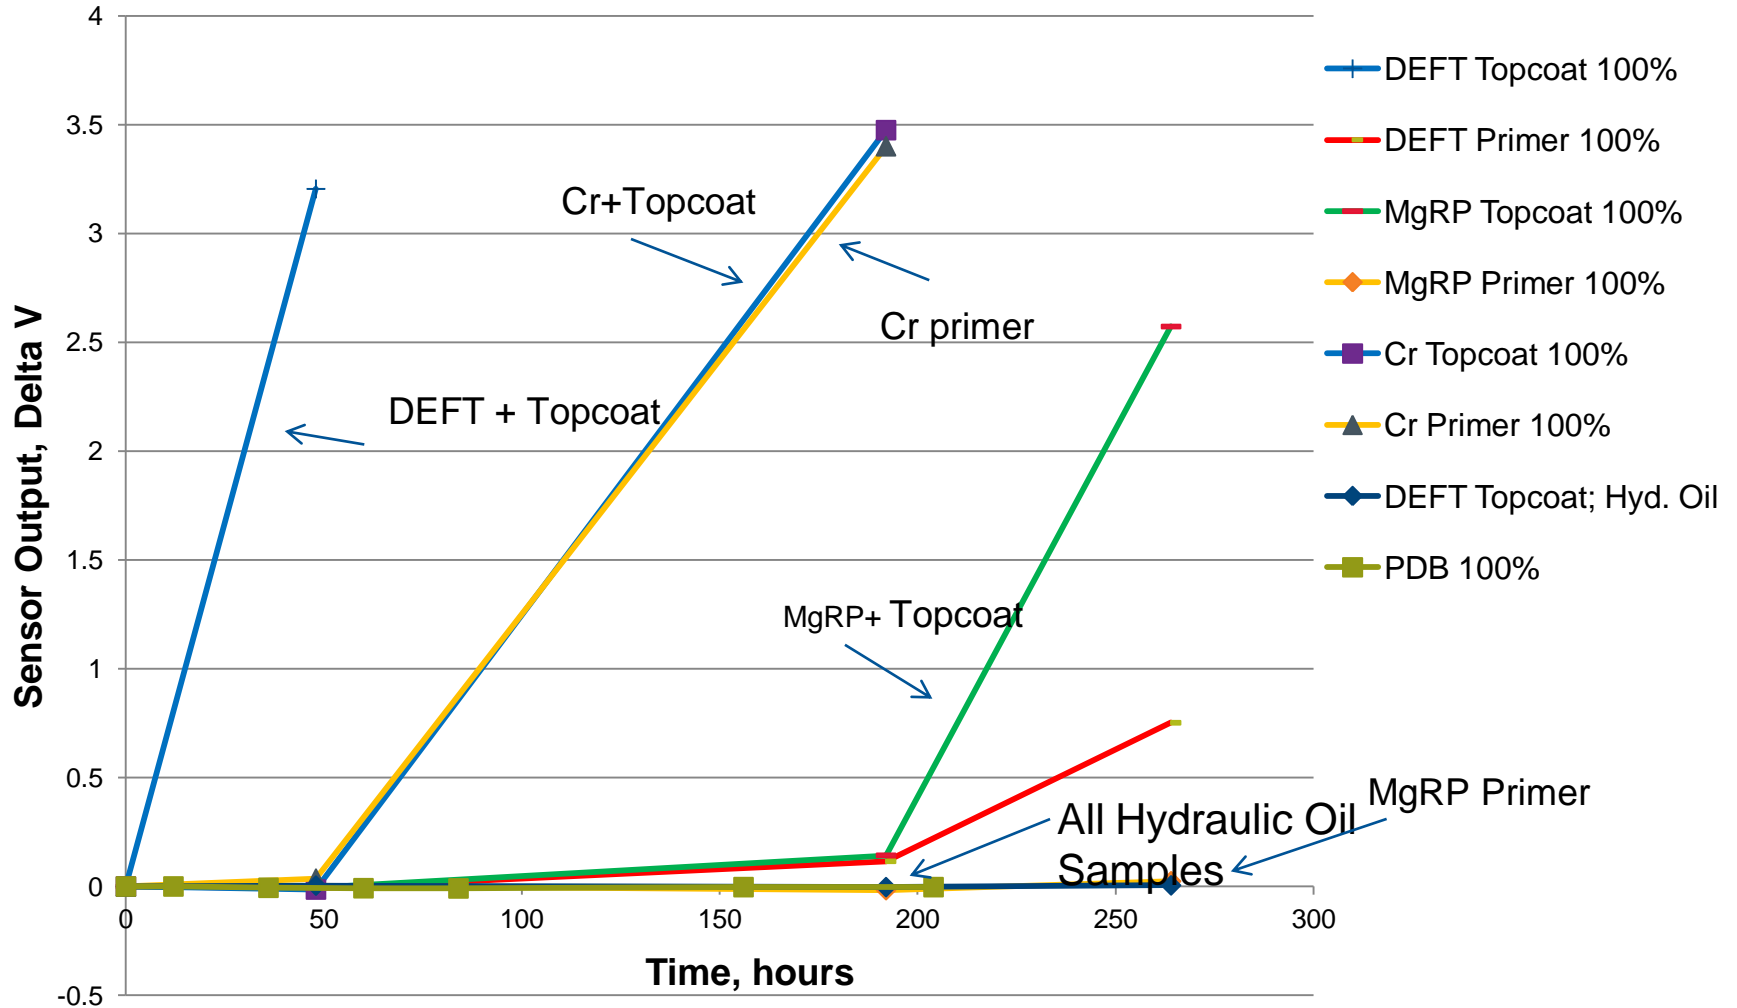
Painted and Scribed Sensors With 3 Primers (w and w/o Topcoats) Treated With Fungal Consortia In PDB Nutrient; Aged 30 C, 100 % rh

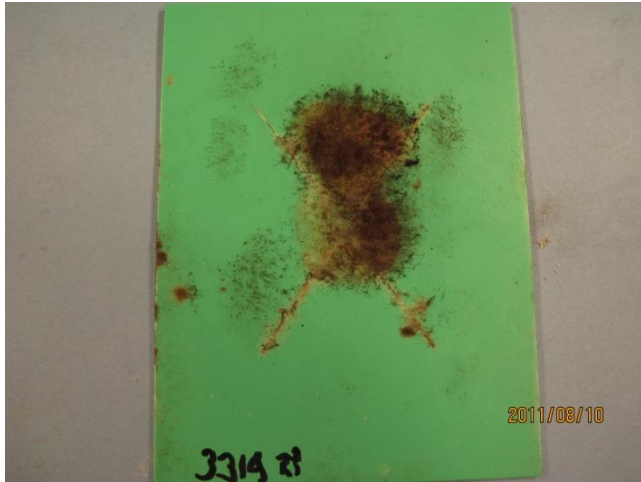
Effects of Fungal Growth on Painted and Scribed 2024 T3 Al With NC Primer Only

Intact Panel; 40 Days, 100% rh

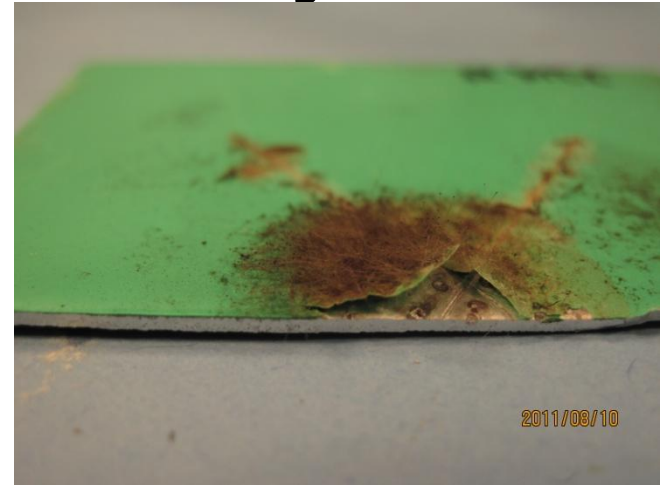
After Cutting at Middle

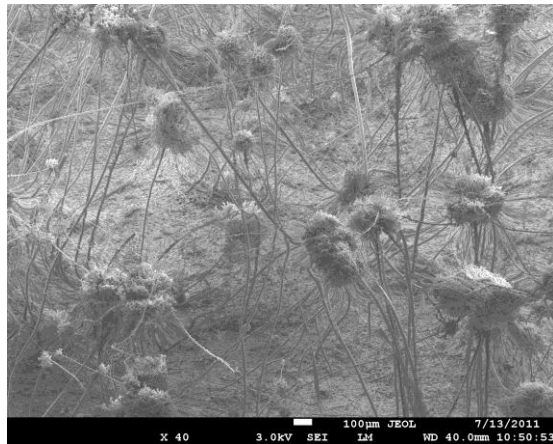
SEM View of Aerial Hyphae/Growth

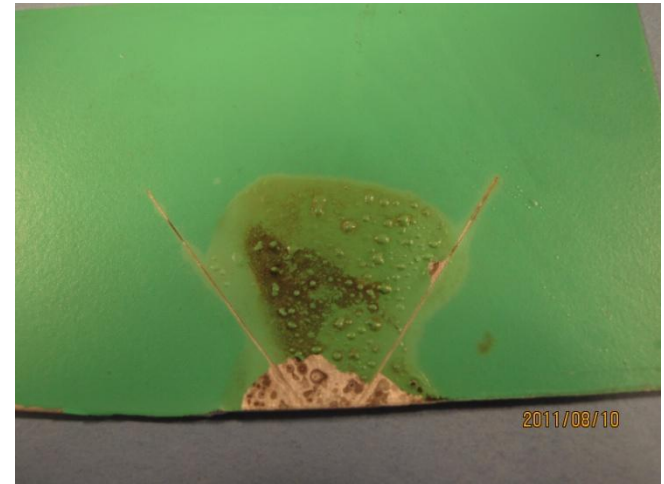
After IPA; Blistering, Pitting
